# *Property Inspection Report*

*Inspection prepared for:*  
*Date of Inspection: 8/19/2017*

Richmond Home

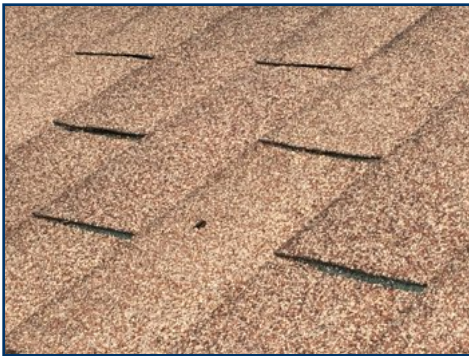
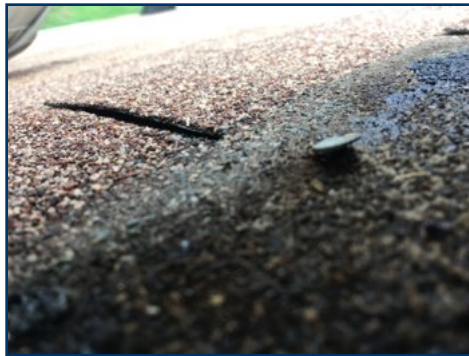
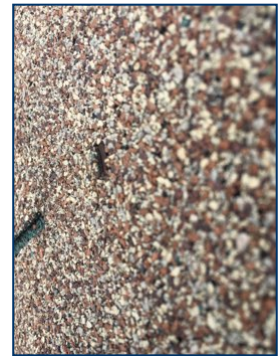
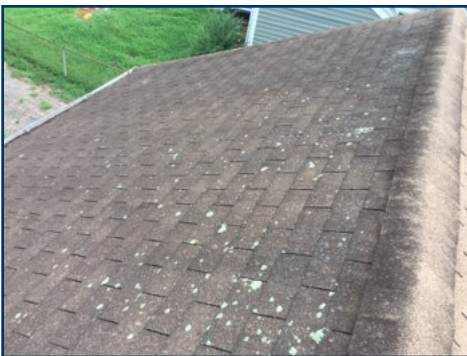
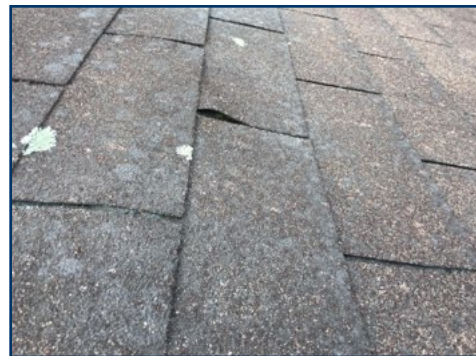
2.1. The roof appeared to be an older installation. No leaks were observed in the attic. I recommend planning and budgeting to replace the roof.

2.2. There were a considerable amount lichens observed on the roof. Lichens can reduce the life span of the affected areas of roof covering. I recommend having all the lichens cleaned off the roof. You wish to add a zinc strip to the roof to prevent a chronic lichen problem.

2.3. Under driven nails were observed on the roof including some that had damaged the shingles creating leak points. This when the roof installer doesn't drive the nails down far enough, or at an angle creating bumps in the shingles. This can damage the shingles and cause leaks. I recommend discussing repair options with a qualified roofer. There is typically no economical repair other than roof replacement. (\$4000-\$6000+) Proper-nailing-shingles.jpg

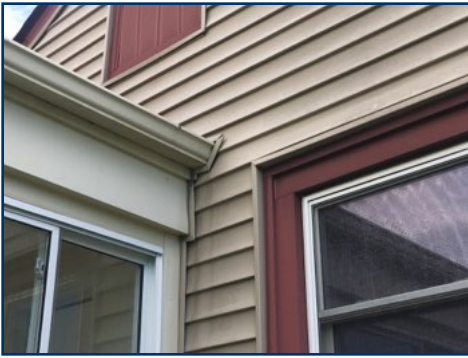
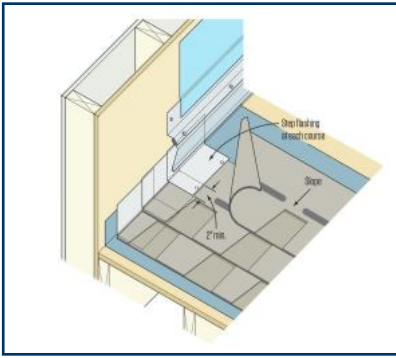
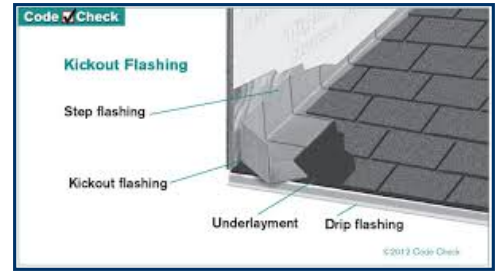
3.1. The side wall **flashing** was continuous instead of stepped. This is more prone to leaks than step flashing. Given the age of the roof, you may be able to wait until the roof is replaced to have the flashing corrected.

3.2. There was no kickout flashing where gutters end at a wall. This sometimes causes damage in the wall. I recommend having kickout flashing installed in these areas. (\$100-\$150+)

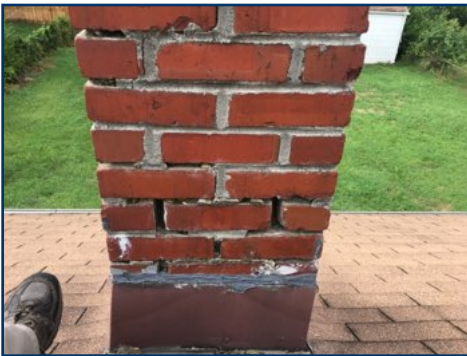
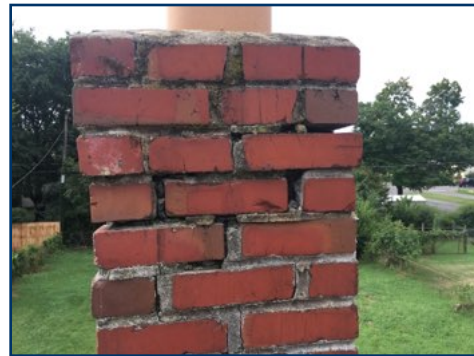
4.2. The flashing on the chimneys is improper. This will leave the chimneys prone to leaks. I recommend having a qualified roofer install proper flashing. (\$300-\$500+)

4.3. There was widespread severe mortar deterioration and loose bricks observed at the chimney. Even though the chimney is not being used, it needs to be maintained (or removed) to prevent damage and leaks into the home. I recommend repair by a qualified contractor. (\$600-\$800+)

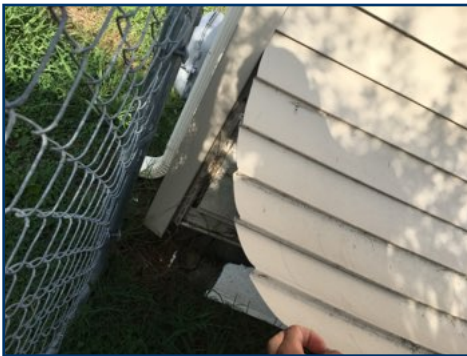
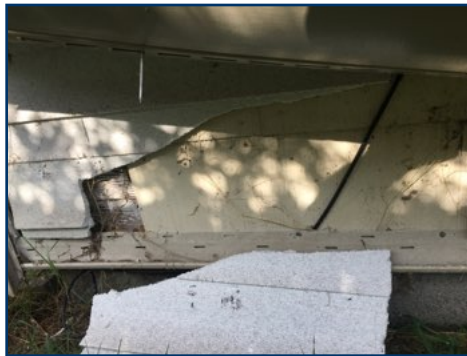
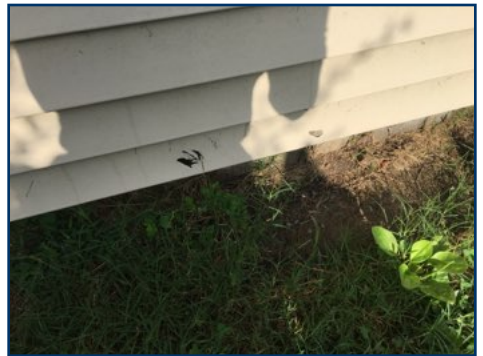
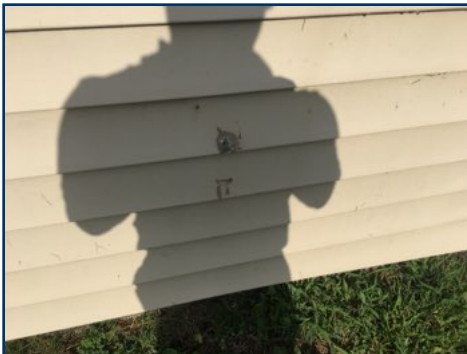
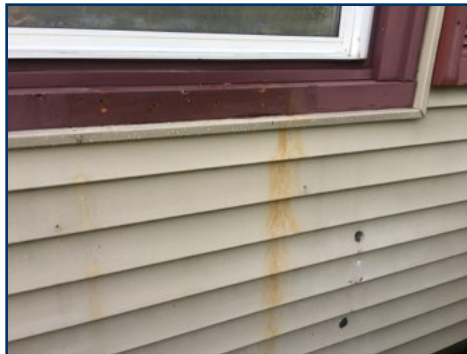
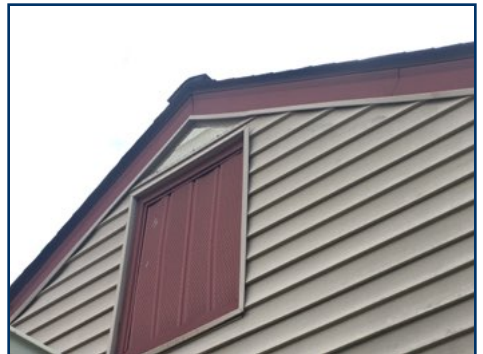
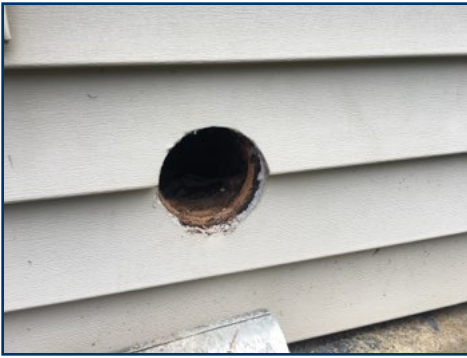
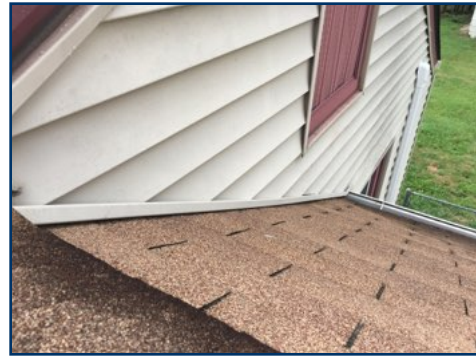
1.1. The bottom of the vinyl siding was in contact with the roof. This can cause heat damage to the siding such as warping and holes. Most vinyl siding manufacturers recommend at least a 1" clearance to prevent this damage. Although there was no damage at the time of inspection, it is possible that it can be damaged in the future necessitating repairs.

1.2. There was siding under the vinyl siding that was consistent with asbestos containing materials. This type of siding is not harmful if it is in good condition. The very limited amount of it that I could observe was in good condition. It is possible that defects exist that I could not observe.

1.3. The siding was loose and unsecured at the bottom on the right side of the home. This may be due to the multiple layers of siding beneath it. I recommend further evaluation and repair by a qualified contractor.

1.4. There were several holes in the window wrap and siding at the front of the house. This can allow moisture behind these areas and cause rot. I recommend repair by a qualified contractor. (\$200-\$300+)

1.5. The siding was not installed properly around the front hose bib making it prone to moisture intrusion and making the hose bib difficult to use. I recommend repair by a qualified contractor. (\$100-\$200+)

1.6. There was a piece of siding missing at the left gable end. I recommend repair by a qualified contractor. (\$50+)

1.7. There was a hole above the crawlspace entrance that had no apparent purpose. I recommend repair by a qualified contractor. (\$100+)

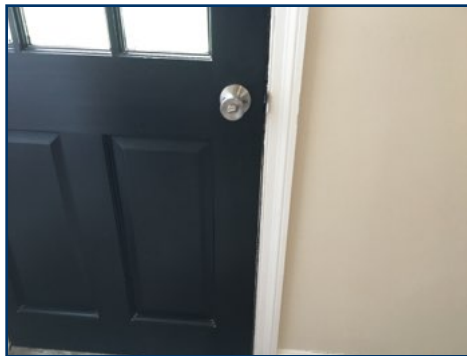
3.3. The front door was not installed properly. When closed, it's loose and light shines through. I recommend repair by a qualified contractor. (\$100-\$200+)

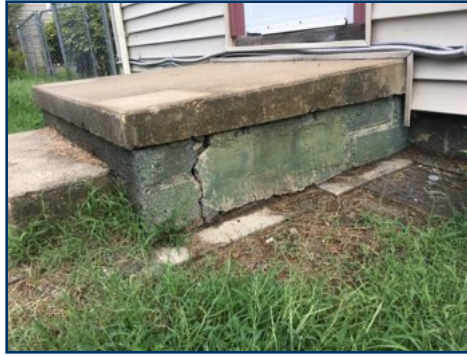
4.1. There were large cracks in the rear steps. I recommend repair by a qualified contractor. (\$600-\$800+)

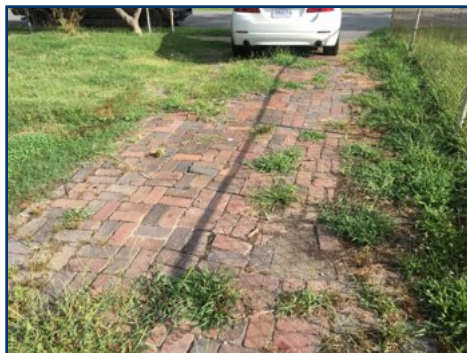
9.1. The driveway was an old brick driveway in relatively poor condition. You may wish to upgrade the driveway.

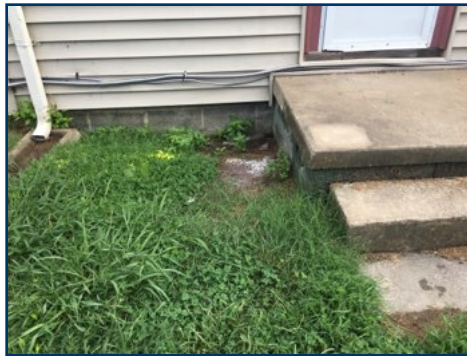
12.1. There are some low spots along the foundation. I recommend adding additional backfill to create the proper slope away from the house to allow for effective drainage. (\$200-\$300+)

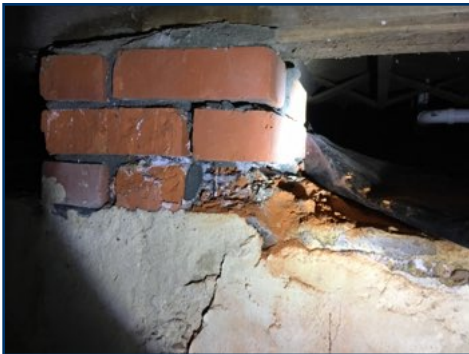
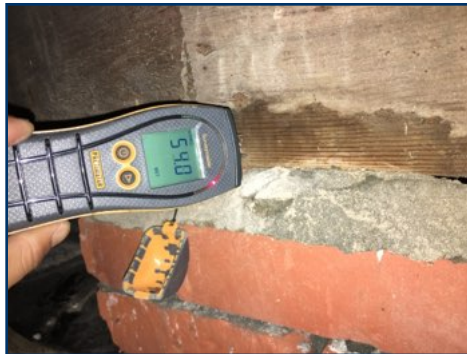
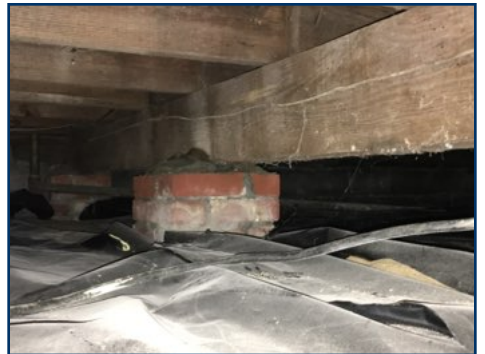
4.1. The middle column in the crawlspace was deteriorating. Columns are main structural supports. I recommend repair by a qualified contractor. (\$400-\$700+)

4.2. There was elevated moisture on the main beams above all of the columns. This is indicative of active moisture intrusion into the crawl being wicked up by the columns. The source of moisture was not apparent. I recommend further evaluation and repairs by a qualified contractor.

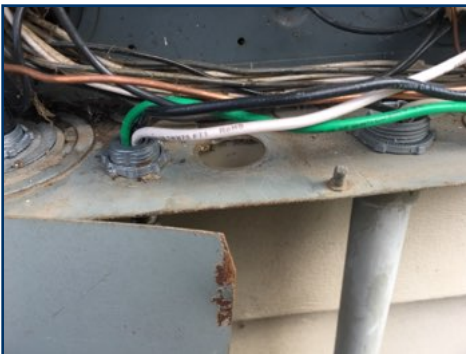
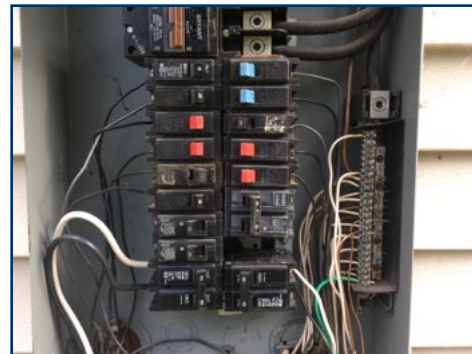
5.1. The main panel had multiple breakers that did not match the brand of the panel. Most manufacturers specifically warn against this on the panel. When brands are mismatched like this, the breakers can have poor connections, can create arcs, damage the panel and pose a safety concern. I recommend correction by a qualified electrician. (\$150-\$250+)

5.2. There was an open knockout in the panel. Insects and small pests can get into the panel and damage the cables. I recommend having a qualified electrician repair as needed. (\$75+)

5.3. The top left 20 amp breaker appeared to have a size 14 wire which is too small. The circuits were not labeled making it difficult to inspect. I recommend further evaluation and repair by a qualified electrician. (\$100-\$200+)

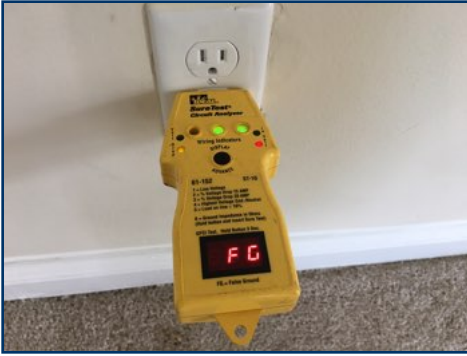
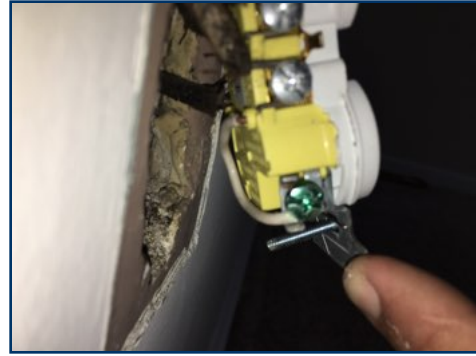
6.1. The receptacles in the house are wired improperly with fake grounds. This is when a jumper wire is installed between the neutral and ground to give a false reading of being properly installed. This is a safety

hazard. I recommend repair by a qualified electrician. (\$500-\$750+)

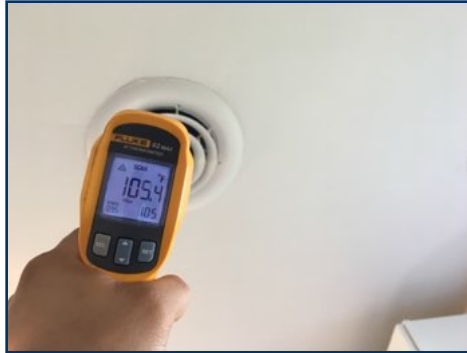
Emergency heat operating

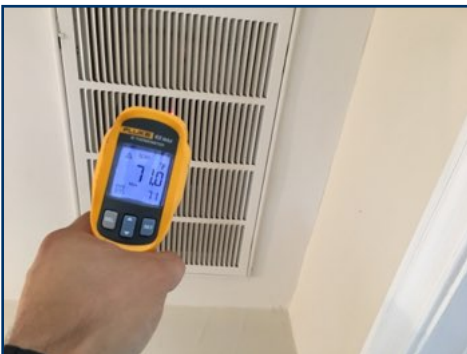
Return air temperature

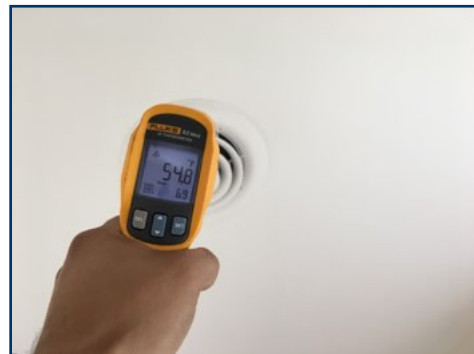
Supply air temperature

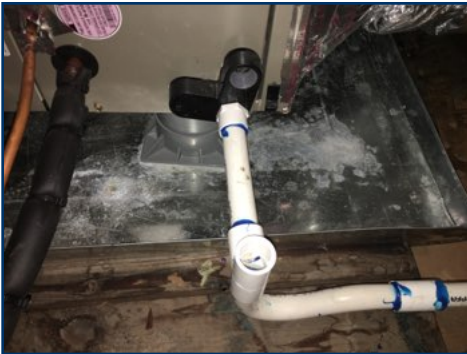
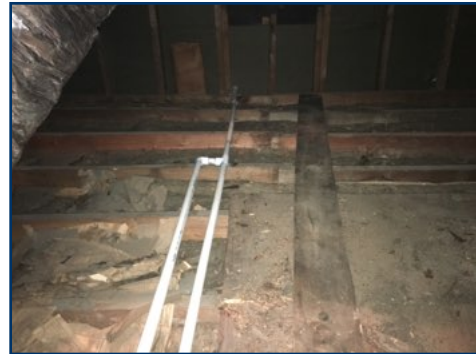
6.1. The primary and secondary drain lines were plumbed together. The secondary drain line is installed to prevent damage to the property when the primary clogs. They should be piped independent of each other. I recommend repair by a qualified HVAC contractor. (\$100-\$200+)

6.2. There was an open vent before the trap at the air handler. This prevents it from draining properly. There was also an open drain line port. I recommend repair by a qualified HVAC contractor. (\$75+)

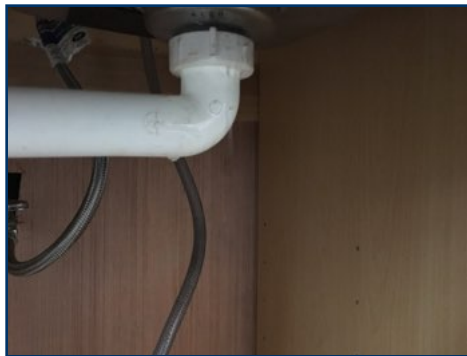
3.1. There was a leak under the kitchen sink. I recommend having a qualified plumber repair as needed. (\$100-\$200+)

3.2. The kitchen sinks drained slowly and gurgled. This can indicate a problem with the venting system. I recommend repair by a qualified plumber.

3.3. The shower faucet and handles in the hallway bathroom were loose. This leaves them prone to damage and leaking. I recommend repair by a qualified plumber. (\$200+)

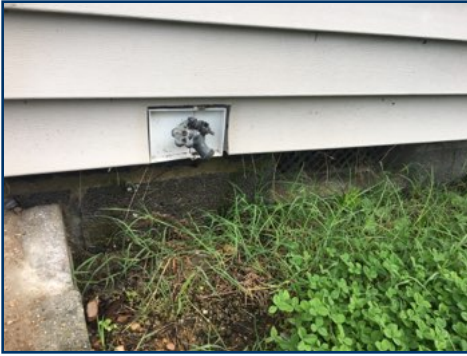
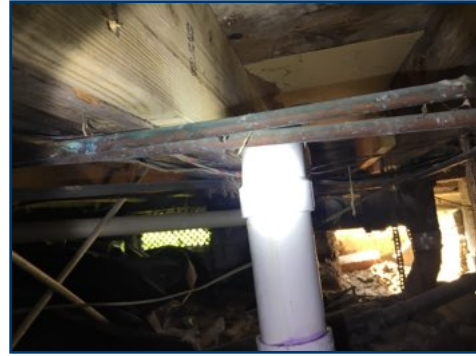
4.2. The rear hose bib was leaking. A qualified plumber should repair as needed. (\$100-\$200+)

4.3. There was a copper pipe leaking in the crawlspace near the drop in access from inside the house. I recommend repair by a qualified plumber. (\$100-\$200+)

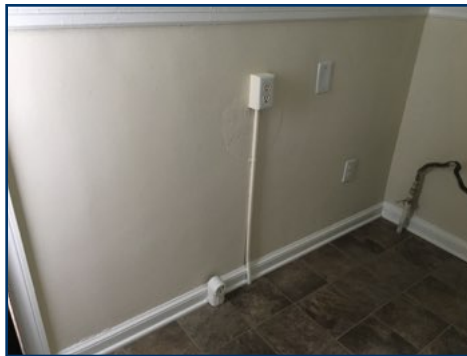
2.2. There was no dryer vent. I recommend repair by a qualified contractor. (\$100-\$200+)

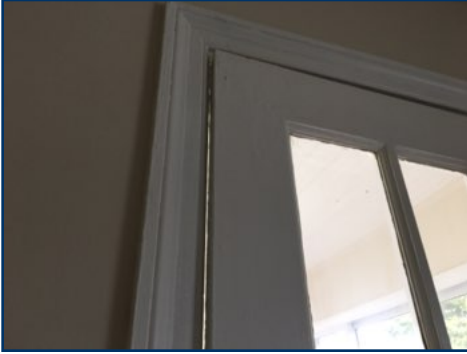
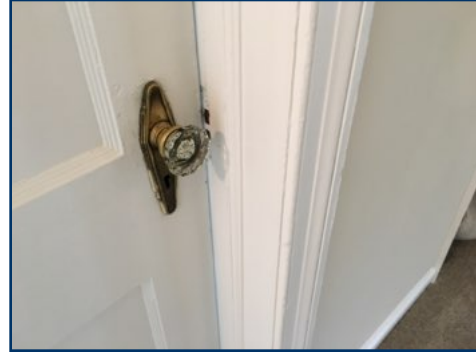
- 1.1. The sunroom door was sticking. I recommend having it adjusted or planed so that it closes smoothly
- 1.2. The bathroom door would not latch. I recommend having the door or the catch adjusted so that it latches closed
