A House on a Rock Home Inspections LLC

Property Inspection Report

123 A House on a Rock Lane, Richmond, VA
Inspection prepared for: Happy Customer
Date of Inspection: 11/21/2013 Time: 10:00 AM
Age of Home: 1995 Size: 2440

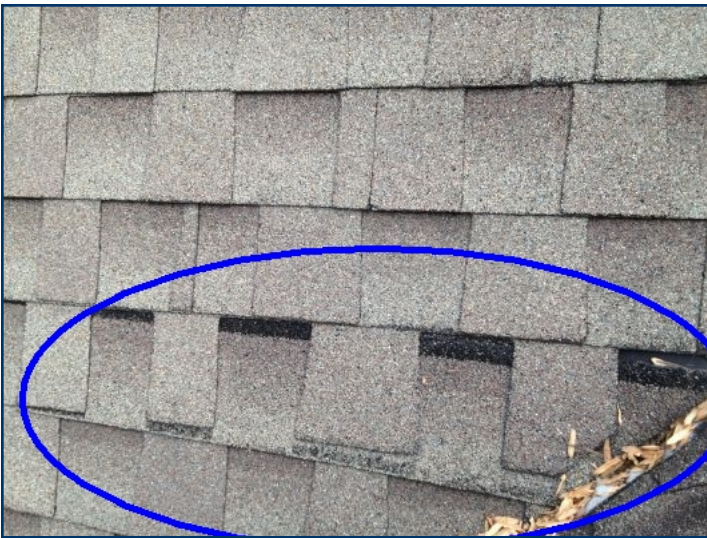
2.3. There was sporadic damage to the roof coverings such as cracked, and torn shingles. (See photos) The roof above the sun room has improper repairs. A qualified roofer should make needed repairs to the roof.

Poorly installed shingle

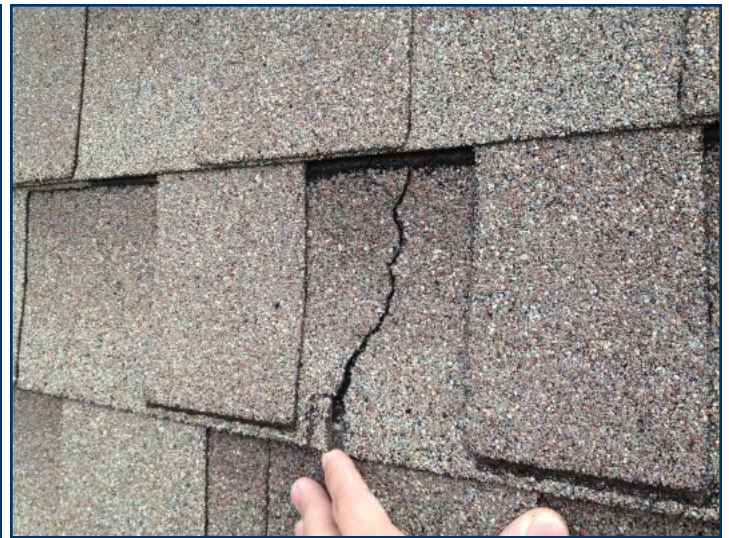
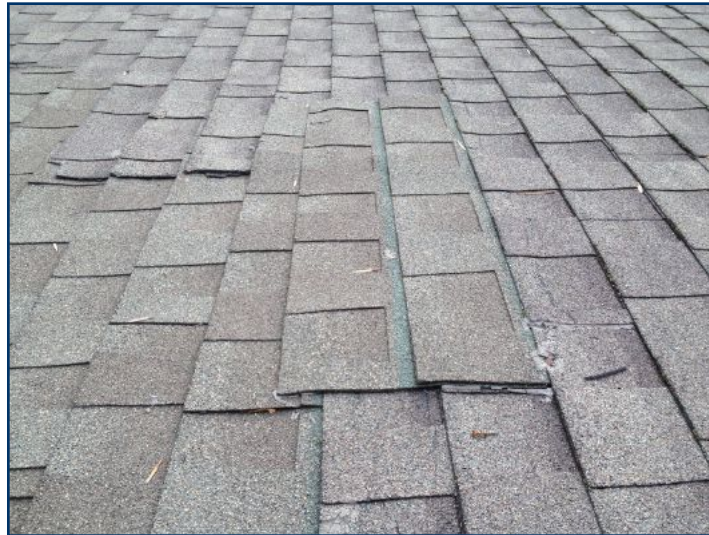
Notice the poor installation of shingles

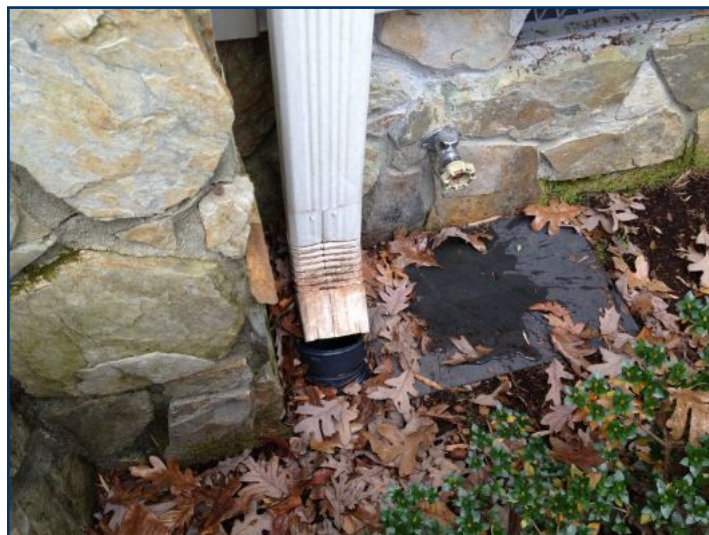
You should get the down spouts to terminate in the drainage tubes

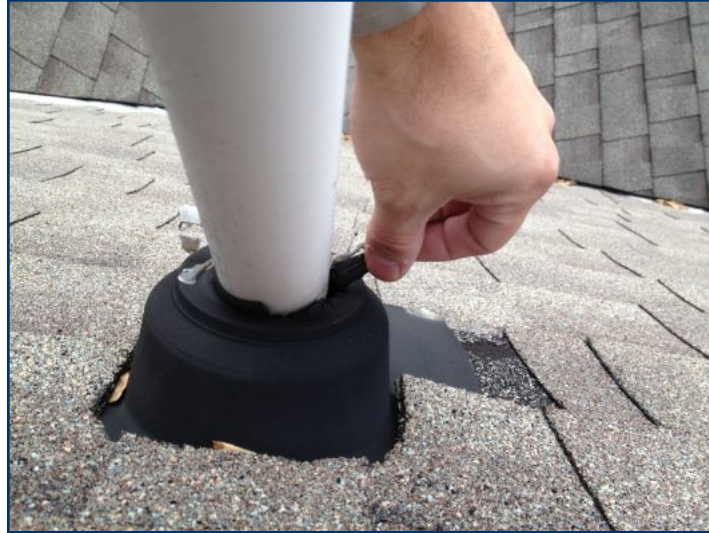
5.1. Two of the plumbing vents had damaged seals (see photo). The seals prevent leaks in the attic. I recommend having the seals replaced.

Torn plumbing vent seal

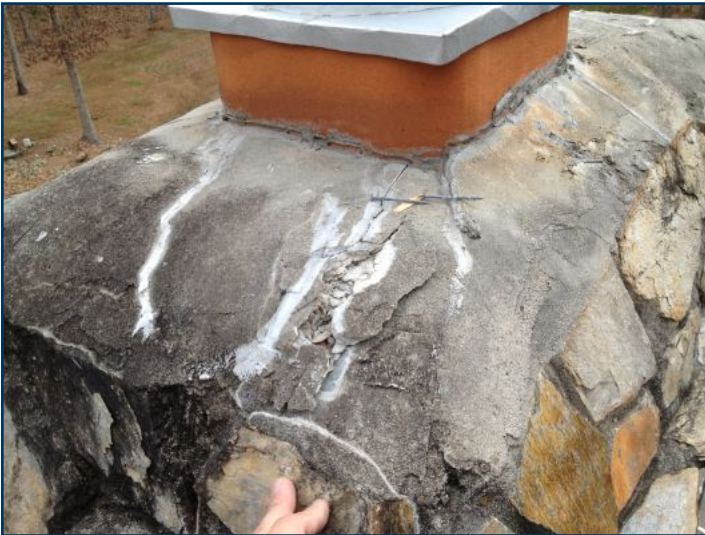
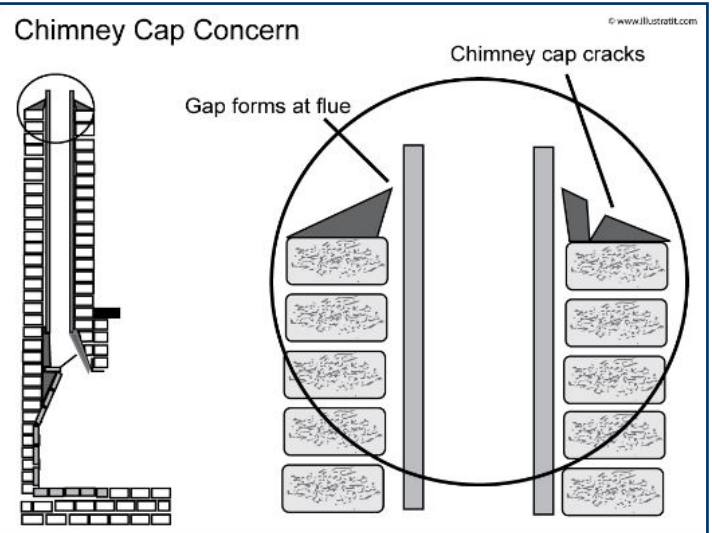
6.1. The chimney crown is cracked or damaged. The crown prevents moisture intrusion into the chimney. I recommend having a qualified mason repair or replace the damaged crown.

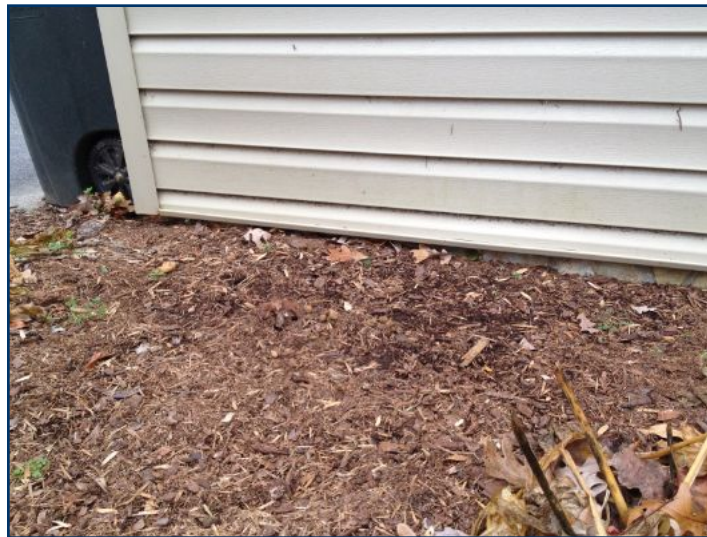
- 1.1. The exterior siding was satisfactory condition at the time of the inspection.
- 1.2. The siding was in contact with the ground. This leaves the siding prone to damage, and can allow termites into the home undetected. I recommend having a qualified contractor correct as needed.

Siding in contact with the grading

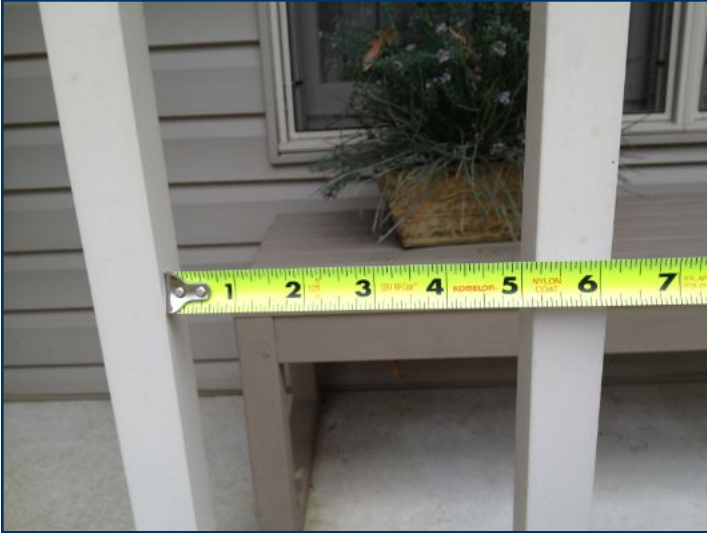
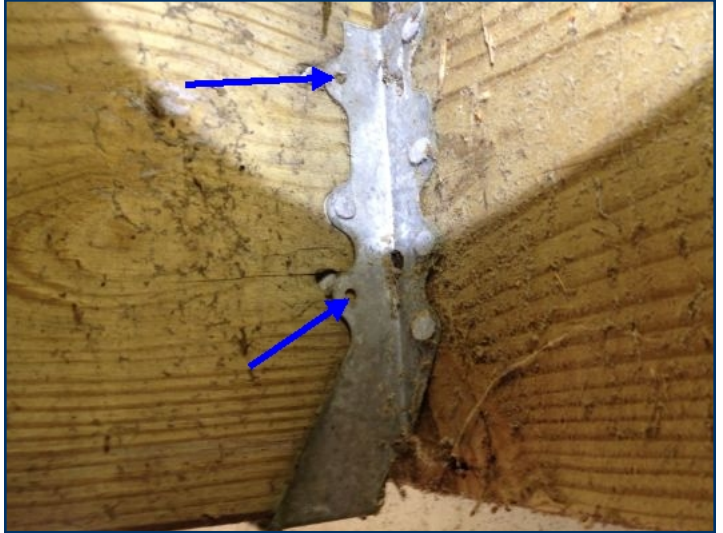
5.1. The deck was in general disrepair. I recommend having a contractor replace or repair warping boards, drive down all nails and screws, and refinish the deck. Having this done regularly will prolong the life of the deck.

5.2. The wooden posts were in contact with soil. You should monitor these areas for rot.

5.3. The balusters on the deck guardrail were farther than 4" apart. This is a safety hazard for small children. The screened in porch represents similar hazards. All of the joist hangers were missing a few nails. The post-to-beam connections are improper. They are not fully bearing on the posts. A qualified contractor should make needed corrections and repairs to the deck.

Missing nails in joist hangers

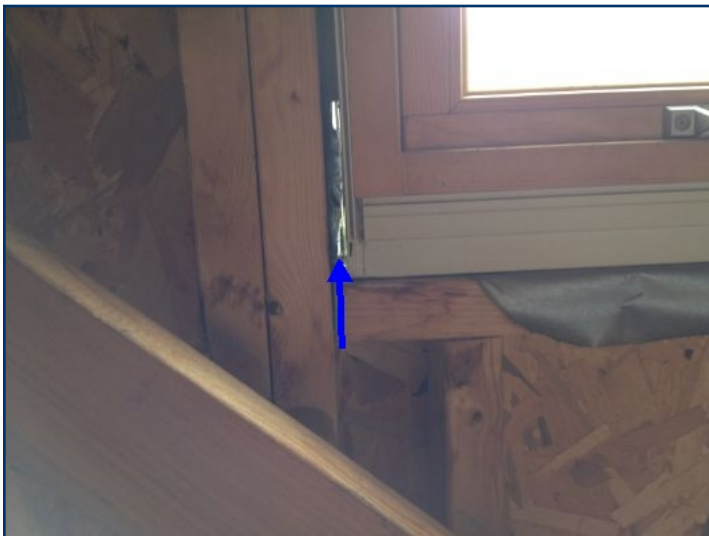
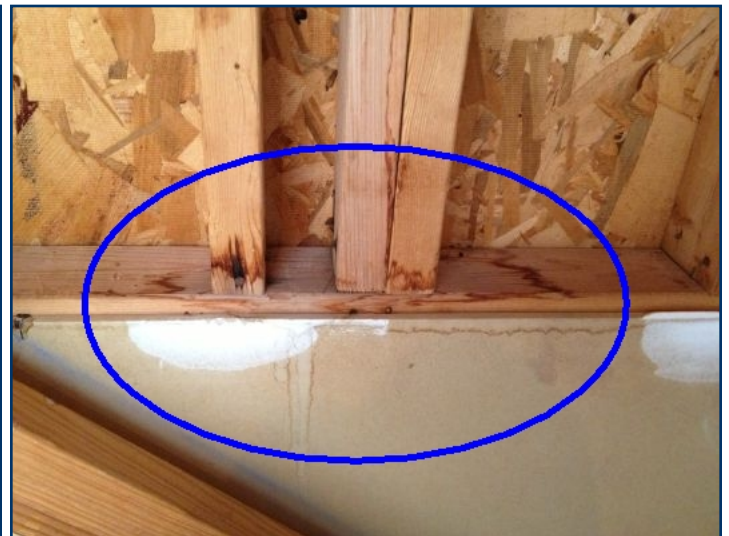
7.1. The windows in the attic space above the garage were installed poorly, and gaps were visible on the sides. Leak stains were observed below the gaps of both windows. I recommend having a qualified contractor repair as needed.

Moisture staining from gap in window

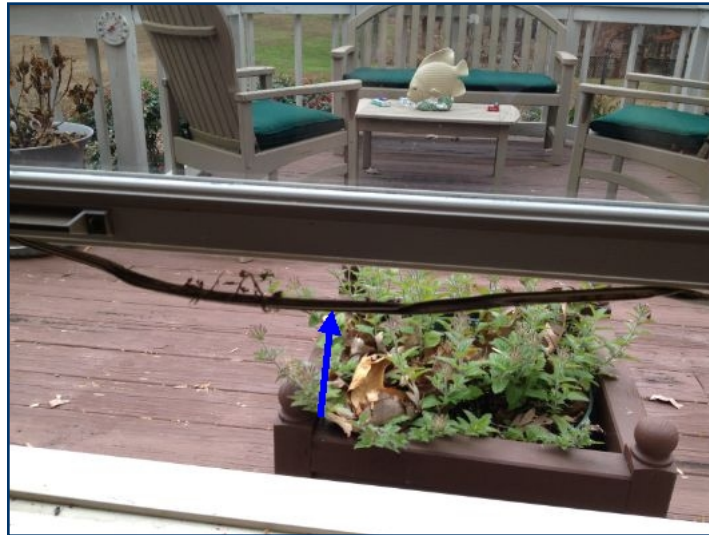
Disbonding seal on dining room window

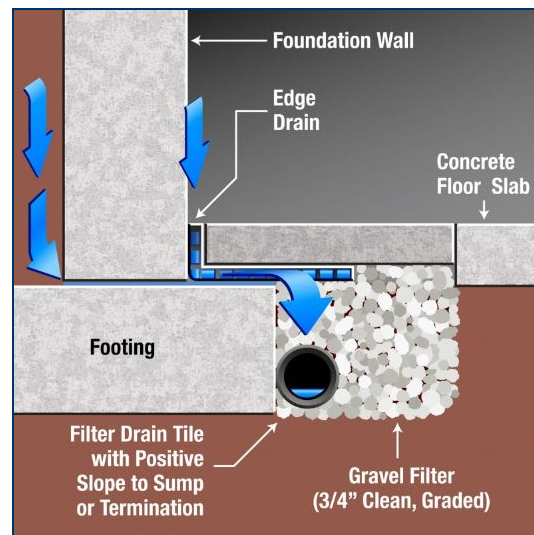
3.2. The drainage tile in the crawlspace floor terminated inside the crawlspace. This is an unusual installation. Typically, drainage tile is installed on the inside, or outside of the foundation wall, near the footer to distribute water away from the foundation, or to a sump pump. I recommend having a contractor further evaluate this installation.

Diagram of drain tile installation

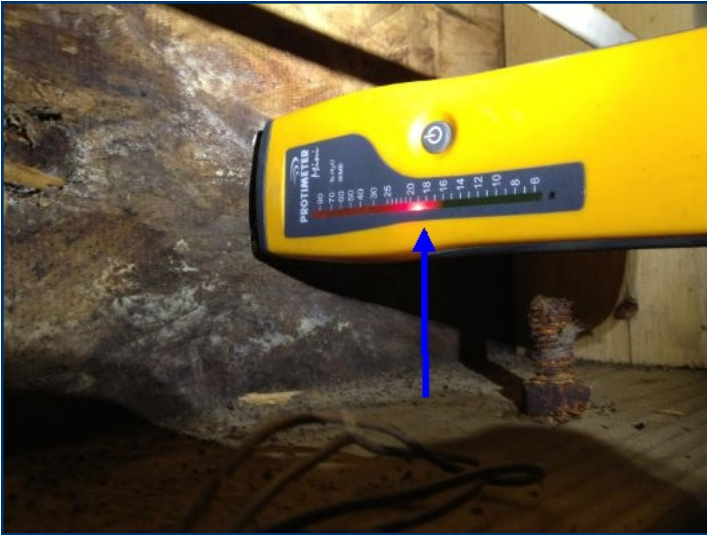
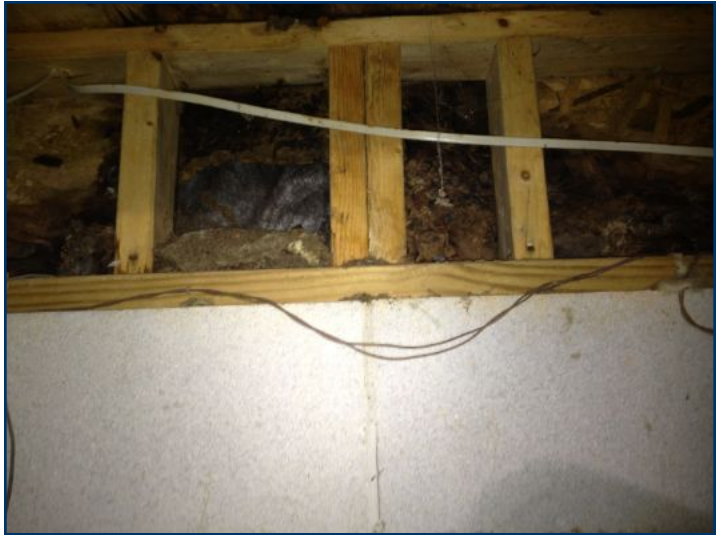
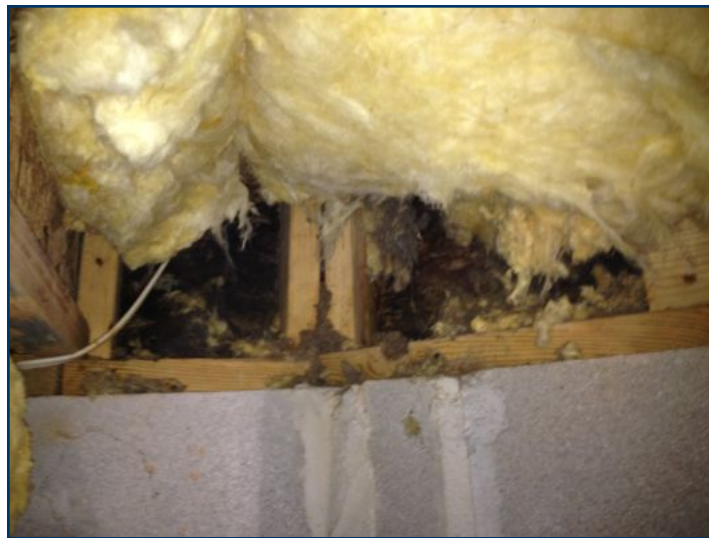
5.1. Two areas of the cripple, above the foundation wall, on the opposite side of the deck ledger board, had moisture damage, and elevated moisture was detected. I recommend having a contractor further evaluate, determine the source of moisture and repair as needed.

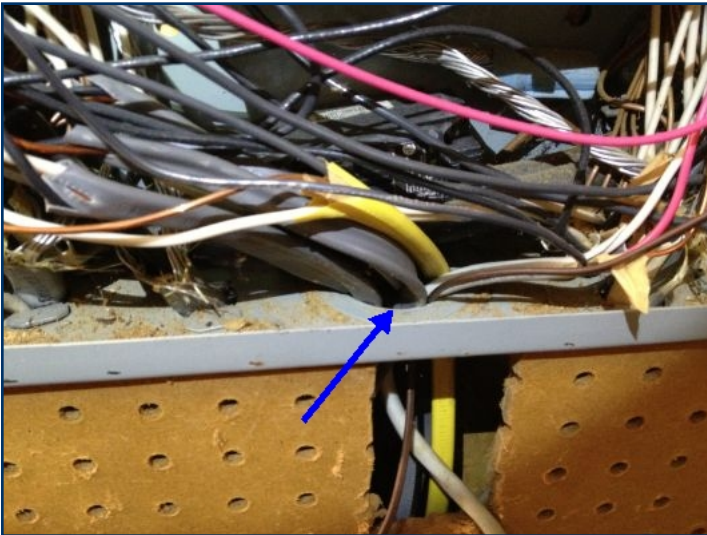
5.2. There were romex cables that were not properly clamped to the box. The edges of the box are sharp so clamps are required to avoid damage to the cable. Additionally, there was a low voltage wire fed by a 15 amp breaker. These are safety concerns and should be corrected by a qualified electrician.

Romex cables going through knockout without clamp or bushing

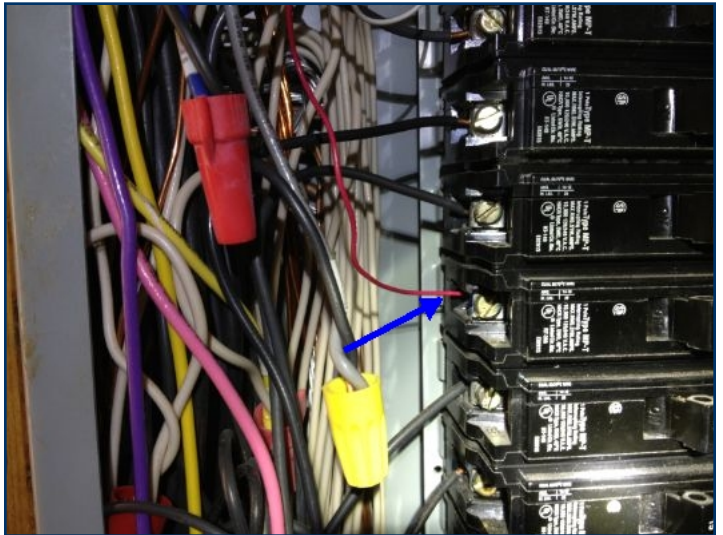
Low voltage wiring in 15a breaker

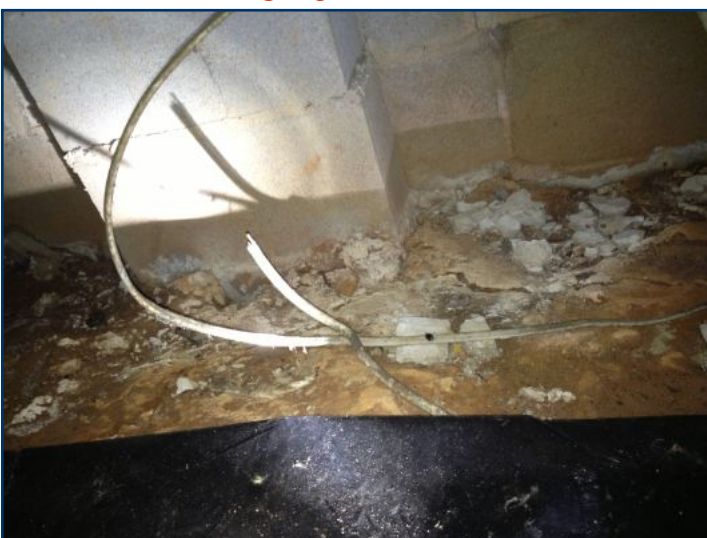
8.1. There was wire in the crawlspace, at the rear wall, that was not properly terminated. It should be properly terminated or removed. There was a junction box in the crawlspace at the front wall that was hanging from the joists. The cables coming out of it were on the ground. The box, and cables should be properly supported. I recommend having a qualified electrician correct as needed.

This romex cable should terminate properly in a box, or be removed.

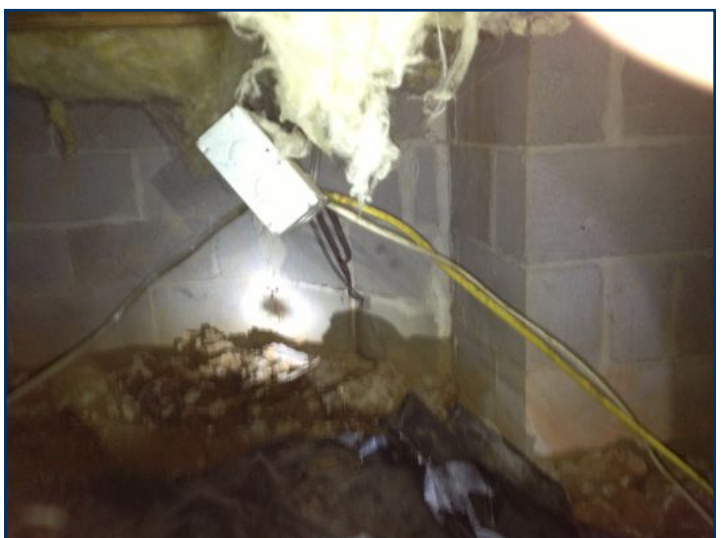
This junction box is not properly secured. The cables were on the ground

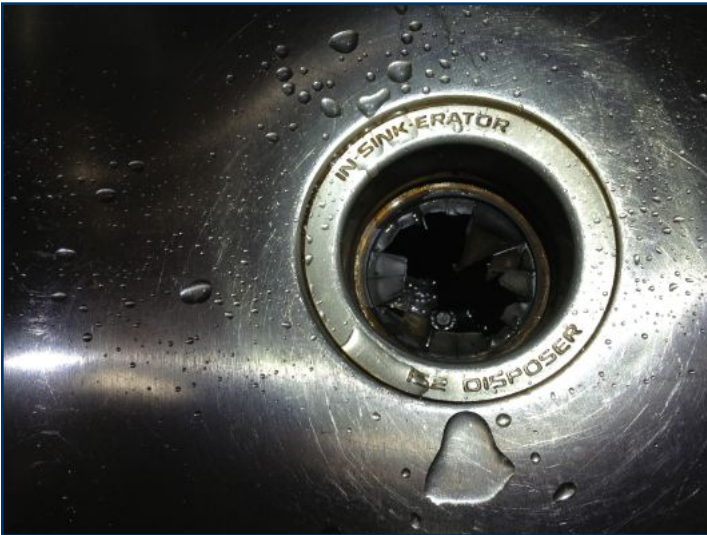
Splash guard broken.

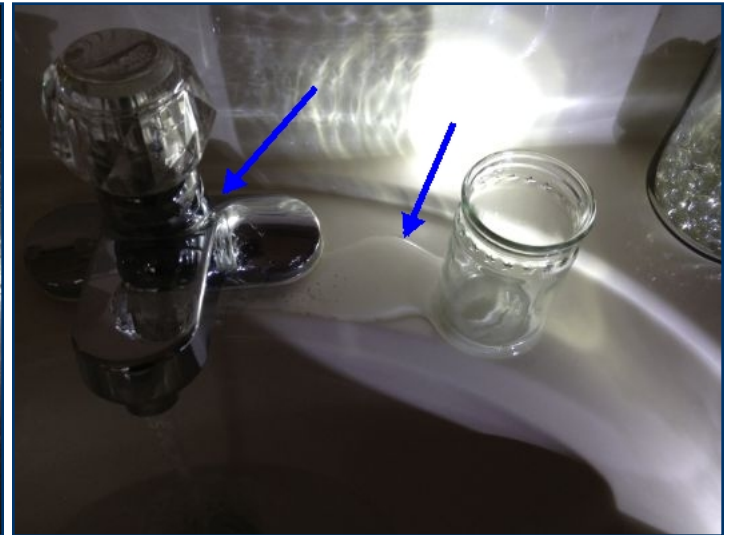
- 5.1. The faucet in the bathroom was leaking from the handle. I recommend having this repaired by a qualified plumber.

Leaking faucet in master bathroom

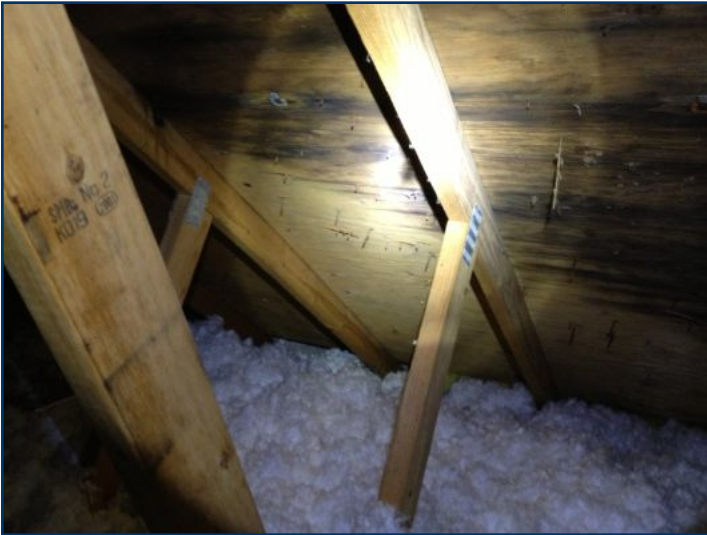
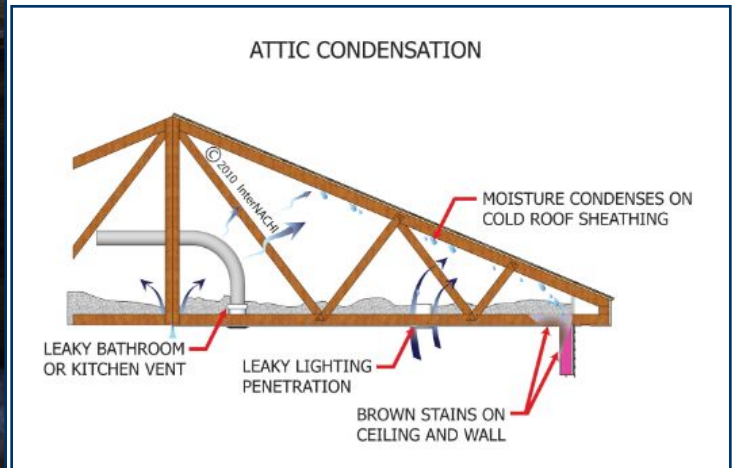
1.1. There were black stains around all of the nails in the attic, and areas of dark moisture staining. This occurs in the winter when warm moist air from the home rises to the attic and condenses on the cold nails and sheathing. I recommend discussing your options for a cure with a qualified contractor.

Notice the dark moisture staining on the sheathing

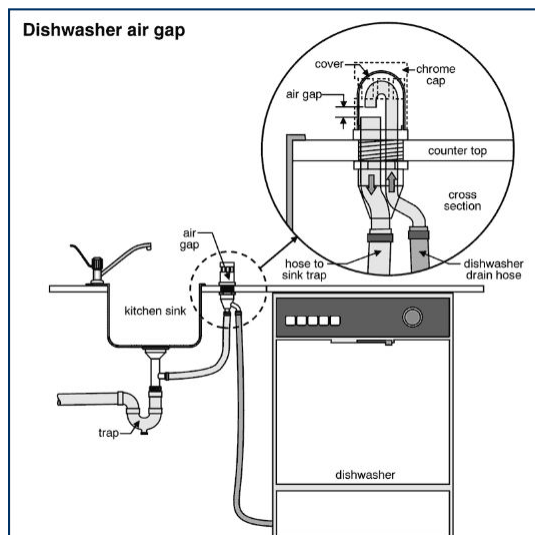
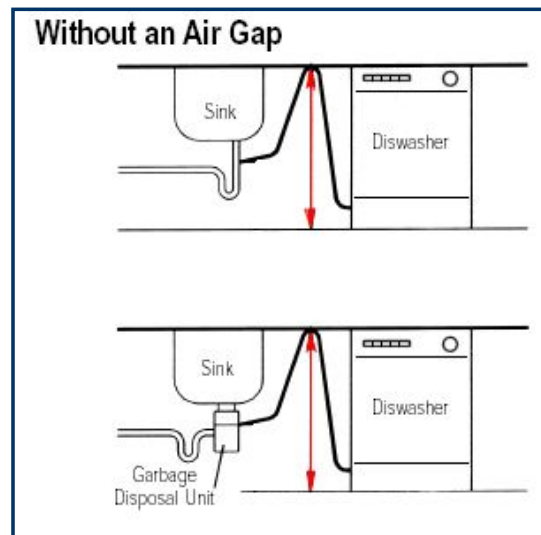
8.2. The dishwasher drain line was not installed with an air gap or drain loop. This can allow the dishwasher to siphon dirty water back into the dishwasher. I recommend having a plumber install a drain loop or air gap.
