Property Inspection Report

Inspection prepared for:
Date of Inspection: 7/30/2015

22456 Richmond Home Lane

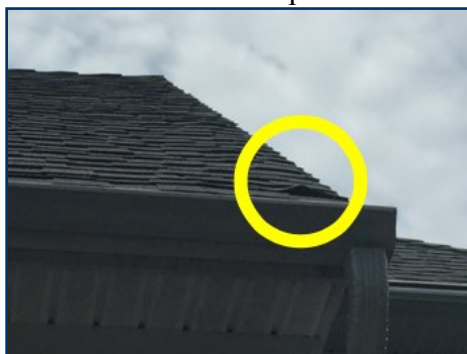
2.1. There was a roof leak observed from in the attic at a **valley** near the first floor furnace vent. Our moisture meter detected elevated moisture indicating it is a current leak. I recommend repair by a qualified roofer. (\$200-\$300+)

2.2. There was one nail pop observed above the garage entry door. I recommend repair by a qualified roofer. (\$50-\$100+)

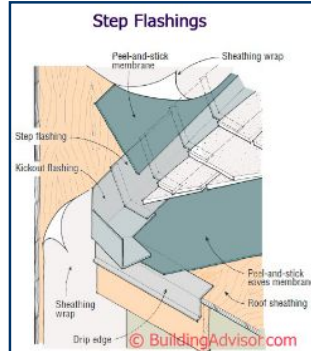
3.1. There was no kickout **flashing** where gutters end at a wall. This sometimes causes damage in the wall. I recommend having kickout **flashing** installed in these areas. (\$150-\$250+)

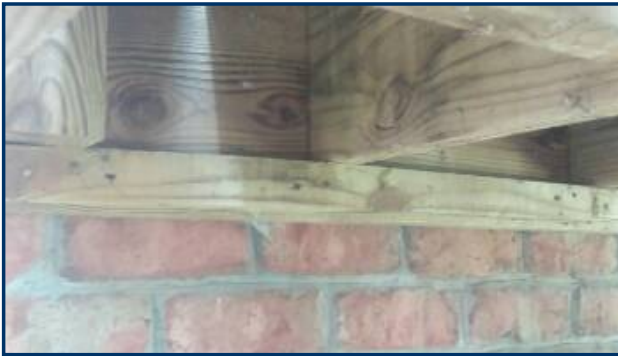
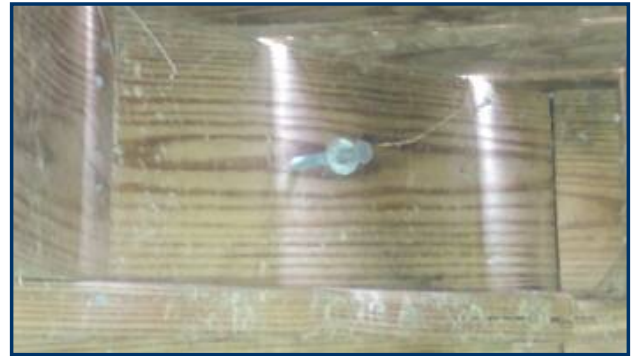
5.1. The deck should be refinished to prolong its life.

5.2. The ledger board was partially attached with nails only and the bolts that were installed were loose and ineffective at supporting the deck. This is a deficient attachment. Ledger Lock screws are approved hardware to correct this condition. I recommend the installation of an appropriate ledger attachment hardware. (\$200+)

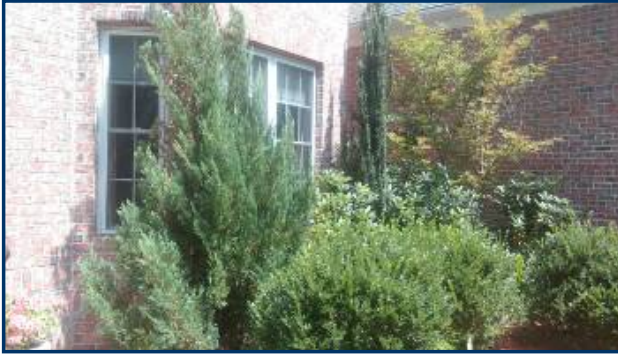
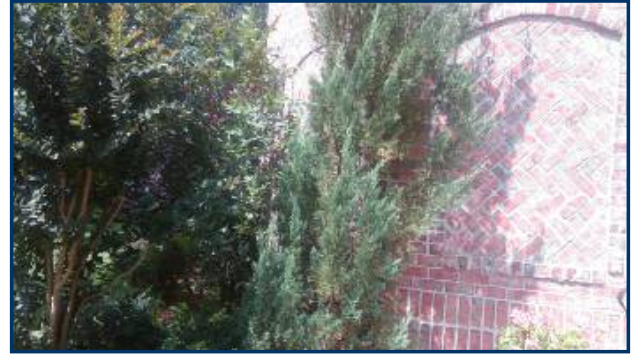
9.1. There was some vegetation in contact with the property building materials. Not only does vegetation limit the inspection, it can damage building materials. I recommend maintaining all vegetation to be at least 6" away from all building materials.

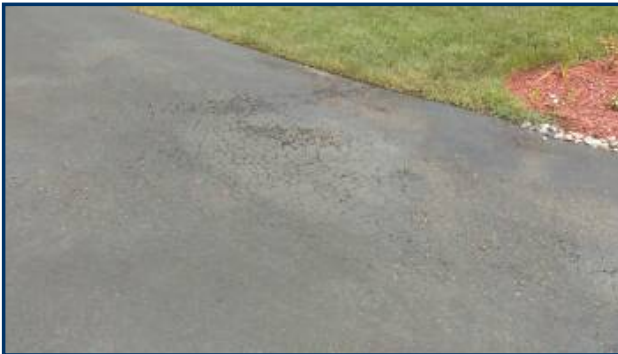
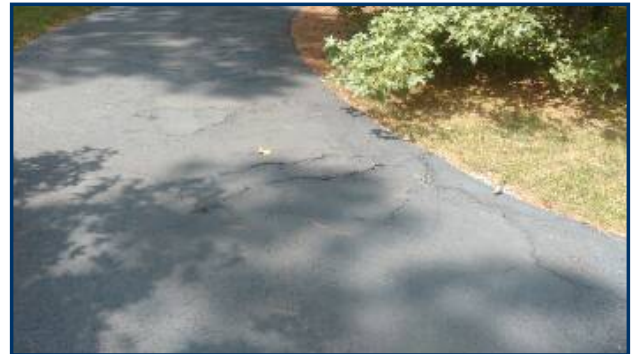
10.1. The driveway had typical cracking and wear and tear. You may want to fill the cracks and reseal the driveway.

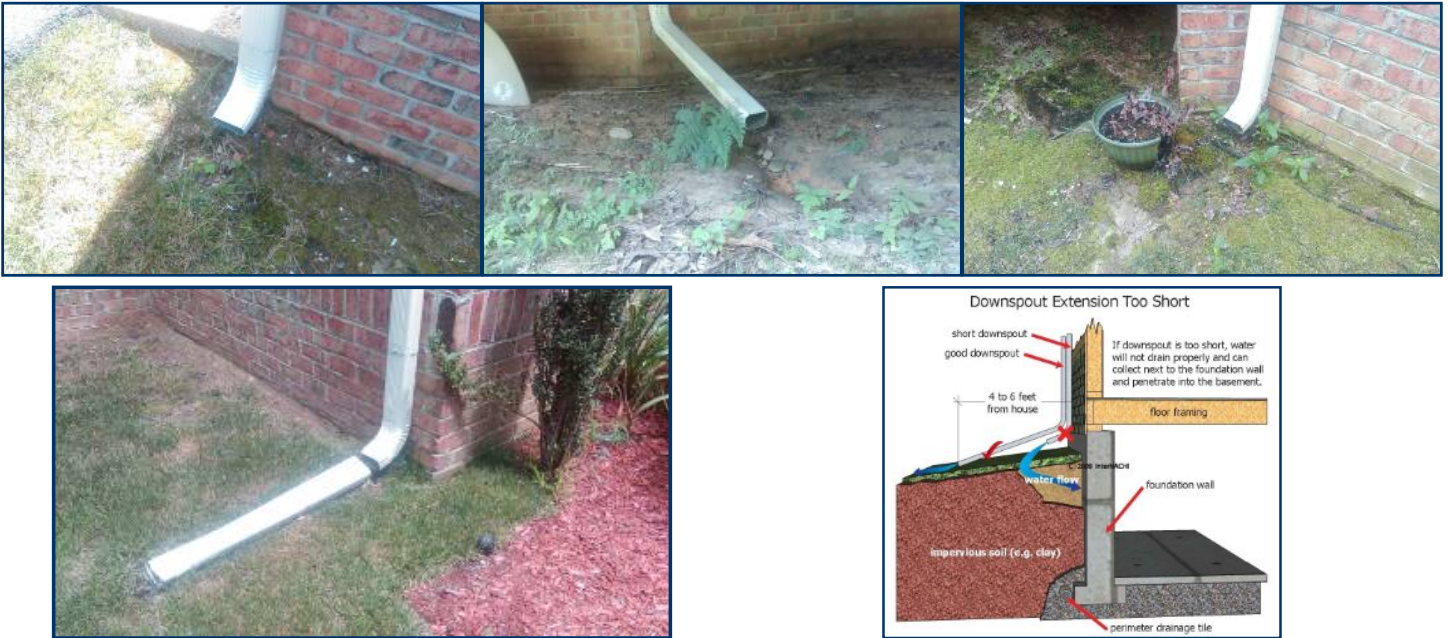
12.1. The downspout at the front right corner of the house has become detached from it's extension. I recommend ensuring that it is attached and allow proper drainage away from the foundation.

12.2. Some of the downspouts terminated too closely to the foundation which was causing erosion of the soil and moisture intrusion into the crawlspace. I recommend having the downspouts extended 4-8 ft from the house. (\$100-\$200+)

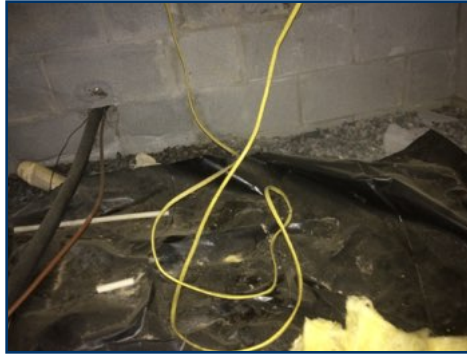
8.2. There was some wiring in the crawlspace was on the ground near the area where the gas line comes through the foundation. Wiring all the floor will be subject moisture or pest damage. I recommend having electrician properly identify this wiring and properly support it. (\$75+)

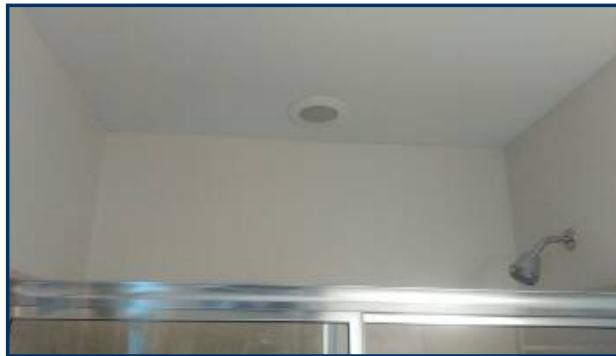
This light fixture in the second floor rear middle bathroom did not turn on. You should have the bulb replaced so you can confirm it works at your final walk through

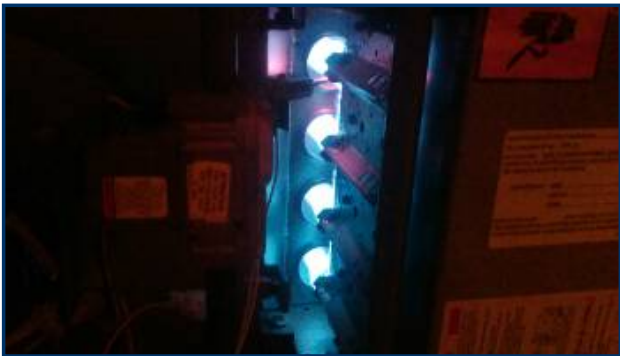
Steady blue flame observed at second floor furnace

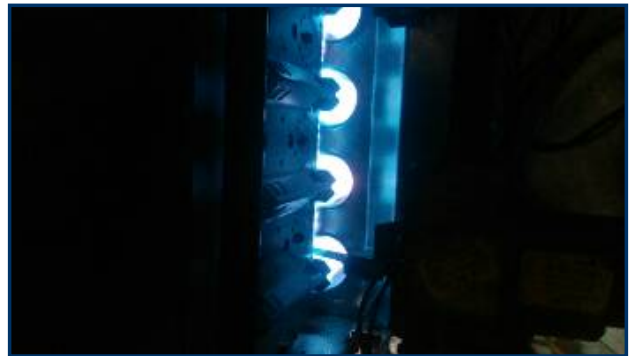
Steady blue flame observed at first floor furnace

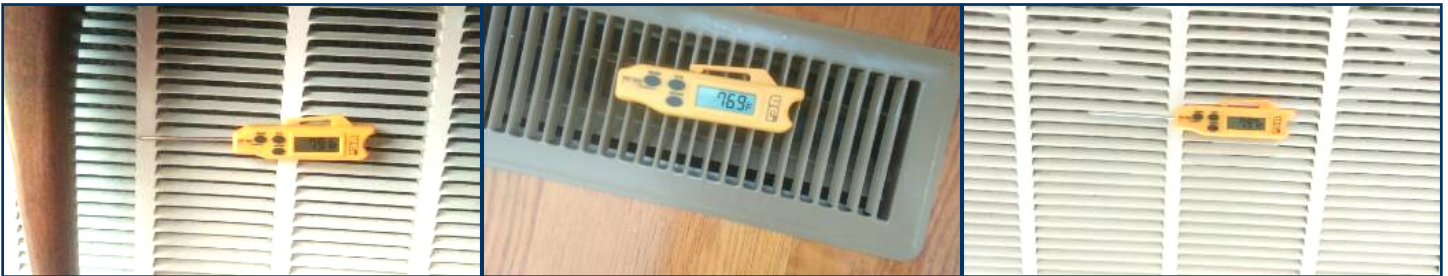
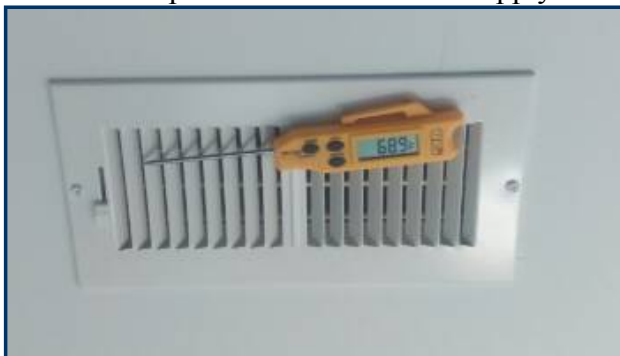
2.1. The first floor air conditioning system had approximately a 3 degree differential between the return air and supply air. A properly operating system typically has a 14-22 degree differential. Although this a very basic test, it is indicative of a problem with the system. I recommend having an **HVAC** technician evaluate the **A/C** system service as needed.

2.2. The second floor air conditioning system had approximately a 10 degree differential between the return air and supply air. A properly operating system typically has a 14-22 degree differential. Although this a very basic test, it is indicative of a problem with the system. I recommend having an **HVAC** technician evaluate the **A/C** system service as needed.

Return air temperature first floor

Supply air temperature first floor

Return air temperature second floor

Supply air temperature second floor

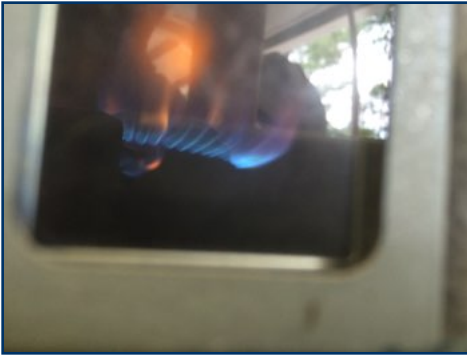
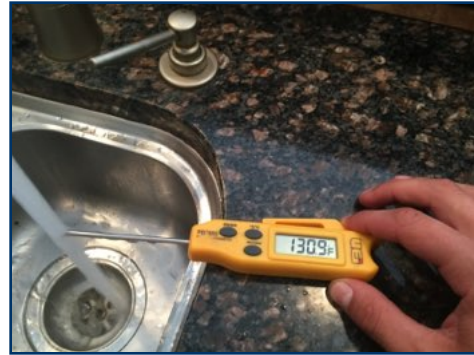
3.1. The right water heater burner had some bright yellow/orange flames. Natural gas should burn blue when the appliance is functioning correctly. I recommend having a plumber service as needed. (\$100-\$200+)

3.2. Knocking sounds were heard when the left water heater was operating. This is often the result of sediment build up at the bottom of the tank. I recommend having a qualified plumber service the water heater as needed. (\$100-\$200+)

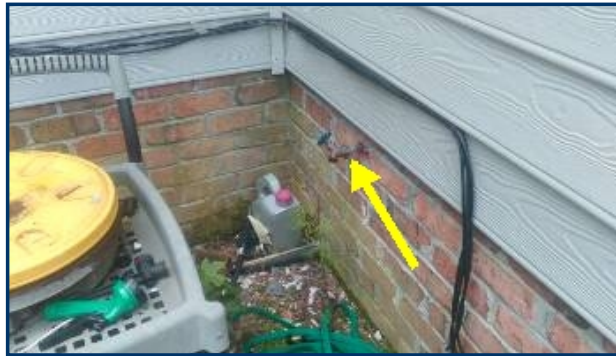
6.1. The hose bib at the left rear corner was loose. This can cause damage to the pipe and leaks. I recommend having it secured. (\$50+)

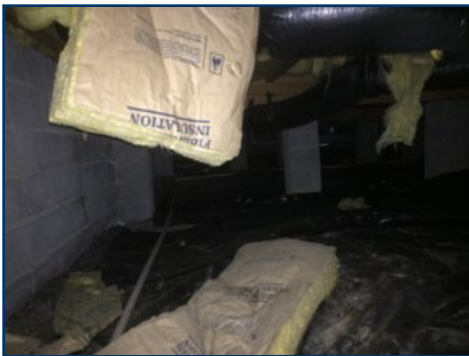
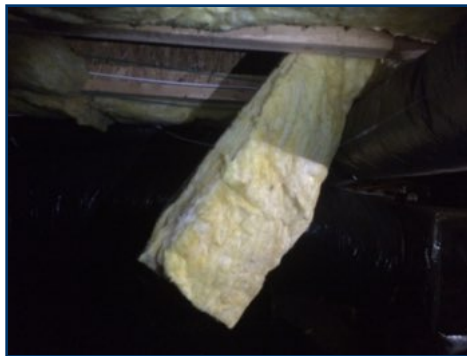
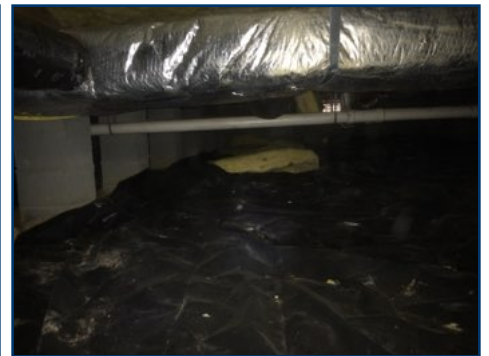
2.1. There were several batts of insulation that had fallen down. You should have these batts resecured, or replaced if damaged. (\$150-\$250+)

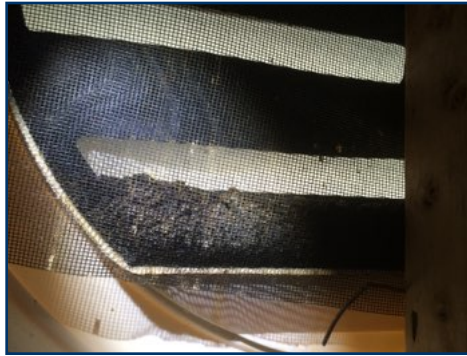
5.1. There was feces in the the circle gable vent that was consistent with guano (bat feces). Guano can be hazardous to your health. I recommend having a qualified pest control specialist evaluate further for bat activity and clean out the feces.
