Property Inspection Report

Inspection prepared for:
Date of Inspection: 7/22/2015

123 Richmond Inspections Lane

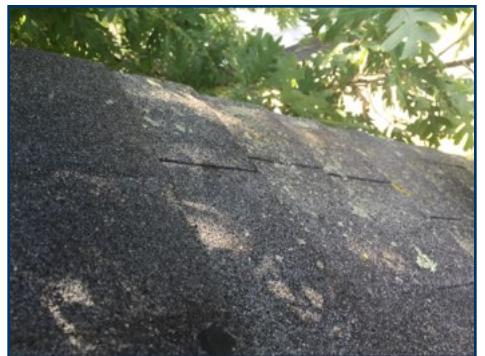
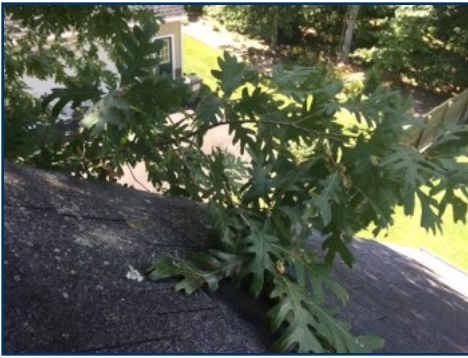
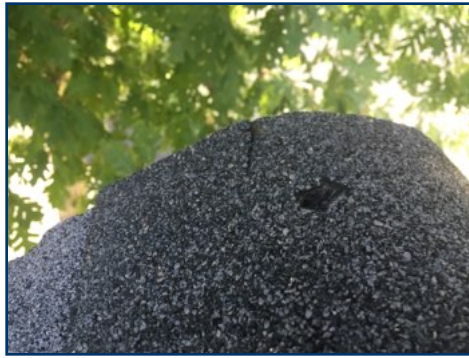
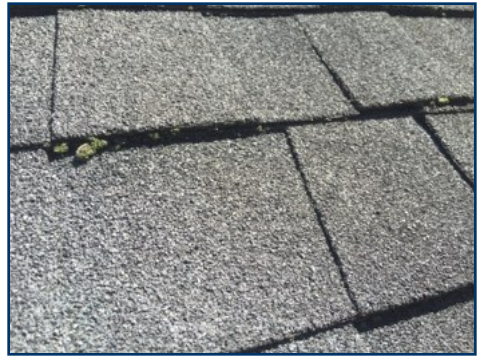
2.4. There was some damage to the roof covering materials at the last shingle on the ridge. (see photos) I recommend having a qualified roofer repair as needed. (\$100-\$200+)

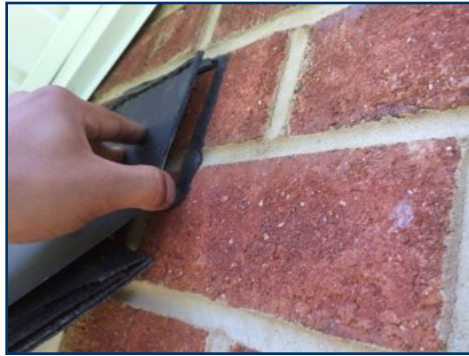
3.2. The headwall flashing at the front of the house were pulling away from the brick. I recommend repair by a qualified contractor. (\$150-\$225+)

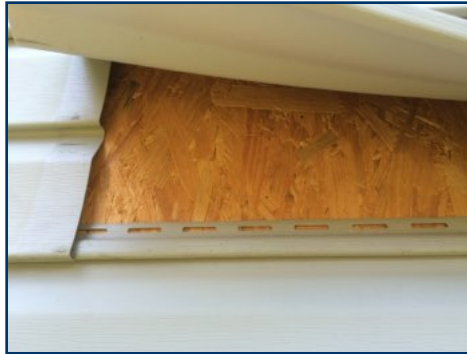
1.1. There was no moisture barrier behind the exterior cladding. This is usually installed to protect building materials from wind driven rain as vinyl siding is not water proof. You will need to be diligent in making sure the siding and caulk is always in satisfactory condition. The sheathing will be more prone to moisture damage.

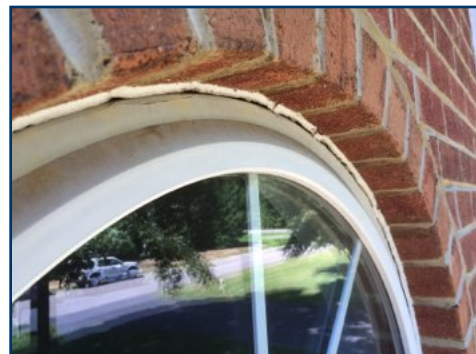
2.1. Some of the caulking around the the house was dried, cracking, or missing. These areas will be prone to air and moisture leaks. I recommend having deficient caulk replaced.

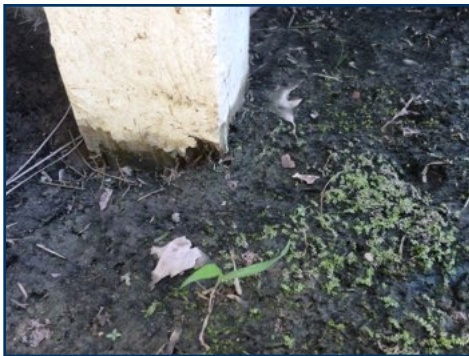
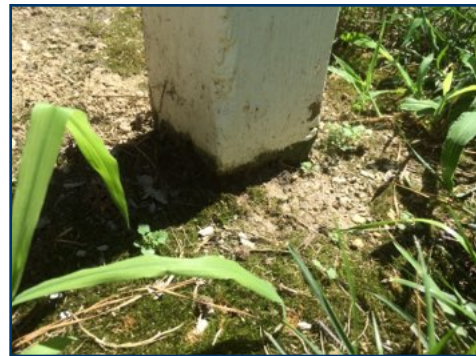
5.1. There were no bolts used for the beam to post connection. Bolts prevent beam rotation and are required by most building standards. I recommend having bolts installed by a qualified contractor. (\$150-\$200+)

5.2. There was rot observed at the bottom of four of the deck posts. Further deterioration can cause more damage to the deck or personal injury. I recommend repair by a qualified contractor. (\$400-\$600+)

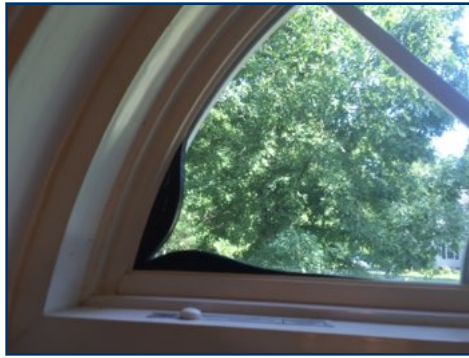
7.1. The arch window in the dining room had a defective seal (see photo). This can cause premature failure of the window and the only way to fix it is to replace the window. (\$250-\$450+)

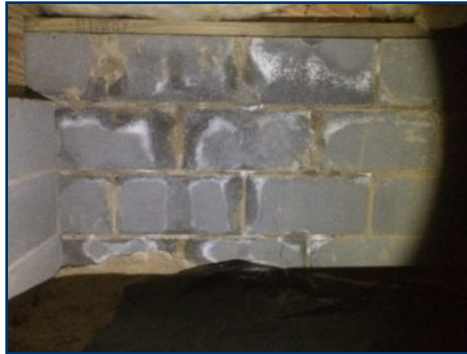
2.1. Efflorescence was observed on the foundation wall behind the front steps. It had not affected the structure. This is a common place for moisture intrusion. I recommend having the area monitored to ensure the structure isn't being affected.

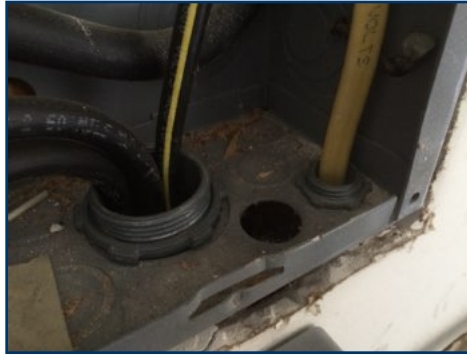
5.1. There was an open knockout in the panel. Insects and small pests can get into the panel and damage the cables. I recommend having a qualified electrician repair as needed. (\$50+)

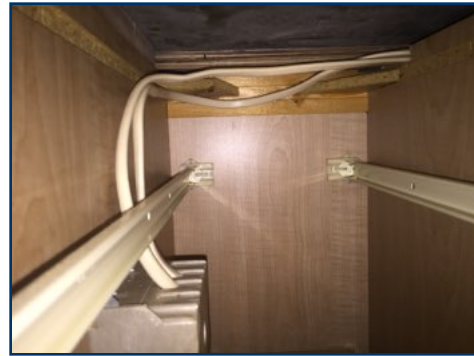
8.1. There was a cut wire observed under the fireplace. I recommend having a qualified electrician properly terminate or remove the wire. (\$100+)

8.2. There was unprotected wiring in the kitchen island. I recommend repair by a qualified electrician. (\$100-\$200+)

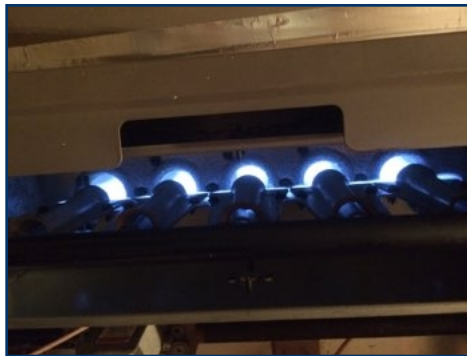
1.1. The heating system was operational at the time of inspection. General maintenance and service will prolong the life of the units.

Steady blue flame observed at furnace

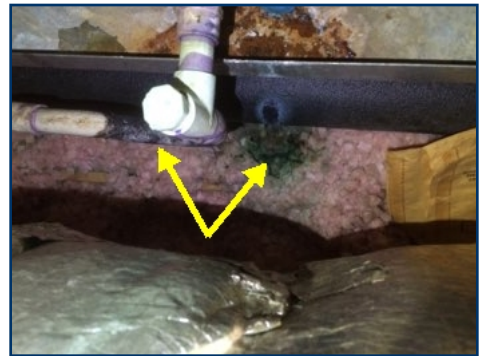
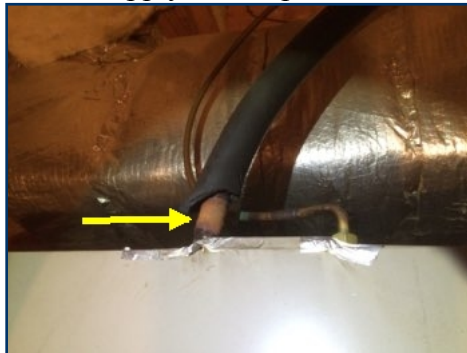
2.2. The refrigerant insulation needs to be extended all the way to the cabinet housing with a gasket in the opening. Any refrigerant line left exposed has the potential to form condensation and leak on building materials below. (\$50+)

2.3. Condensation was forming on the condensate drain line trap. Over time this can damage what it drips onto below. I recommend repair by a qualified HVAC tech. (\$50+)

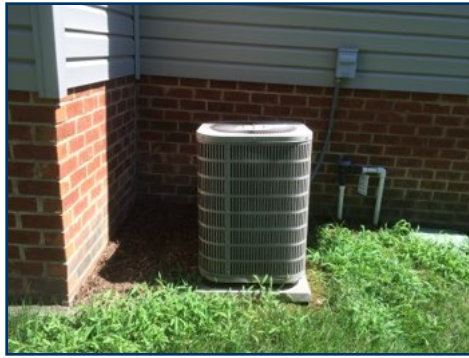
3.1. The condensing unit was not level. Most manufacturers require that the condensing unit be level. I recommend having the unit leveled. (\$50-\$100+)

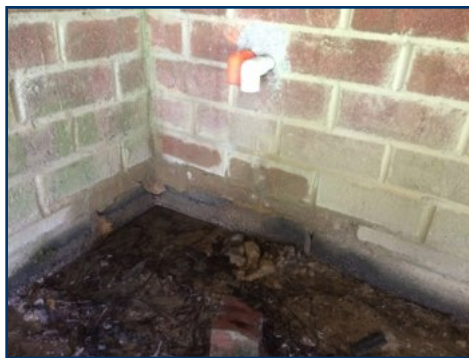
7.1. The condensation drain line terminated too close to the foundation which can cause moisture intrusion into the foundation. I recommend having a splash block installed or other means to direct the water away from the foundation. (\$10-\$50+)
