# *Property Inspection Report*

*Inspection prepared for:  
Date of Inspection: 6/13/2015*

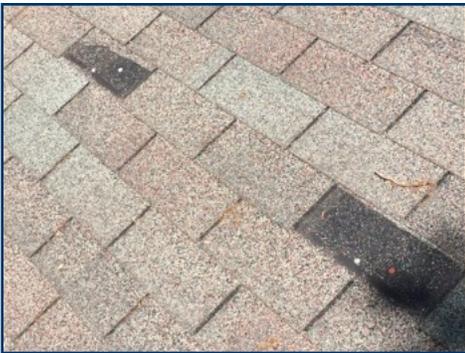
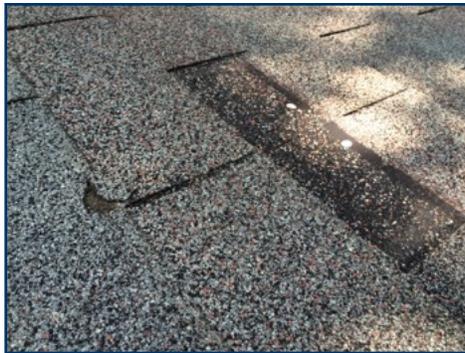
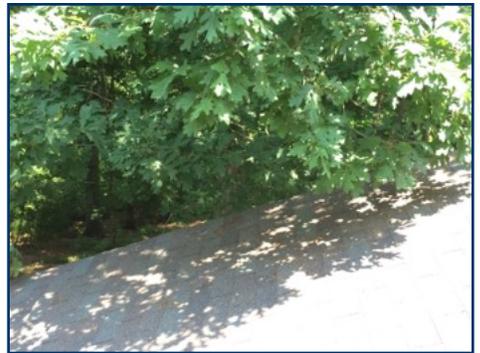
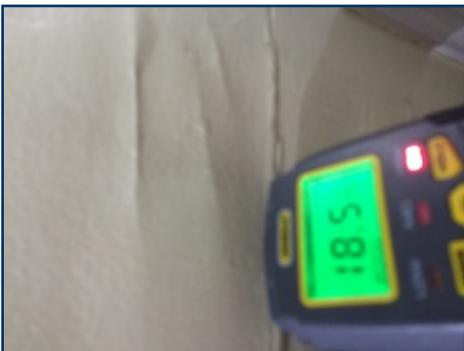
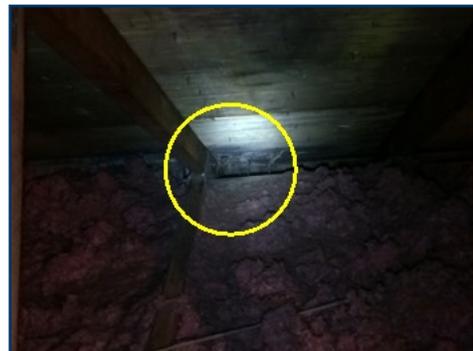
2.1. There were some tree branches close too and/or in contact with the roof. Tree branches can damage roof coverings. I recommend having a tree branches trimmed away from the roof to prevent damage. Make sure you monitor for the condition regularly.

2.2. There were multiple missing shingles observed. These areas will be prone to leaks and further damage. I recommend having a qualified roofer repair as needed. (\$200-\$300+)

2.3. There was leak staining and damaged sheathing observed in the attic near the chimney and elevated moisture observed in the wall finishing materials around the fireplace in the basement. I recommend a qualified roofer repair as needed.

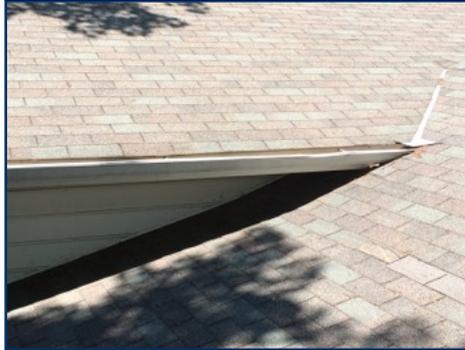
3.2. The siding was low and prevented me from confirming that step **flashing** was installed at the sidewalls. It is possible that defects exist that were not observed.

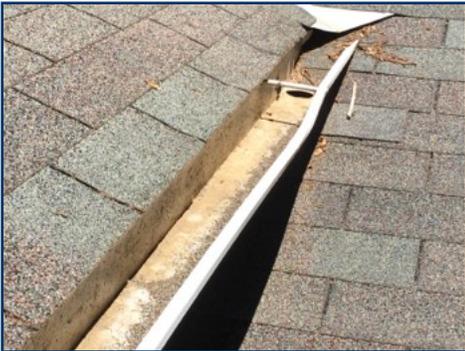
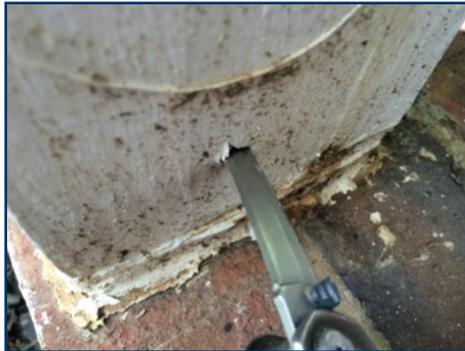
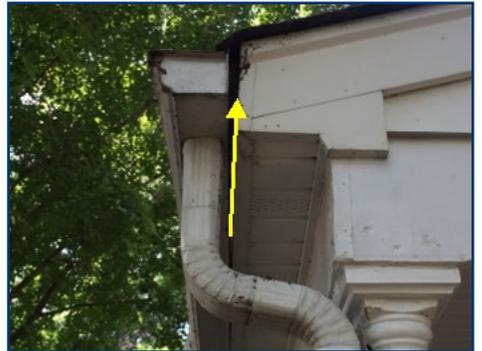
4.1. There was a gap between the gutters and the fascia and moisture damage was observed on the post directly below. I recommend having a qualified contractor repair the gutter. (\$500-\$100+)

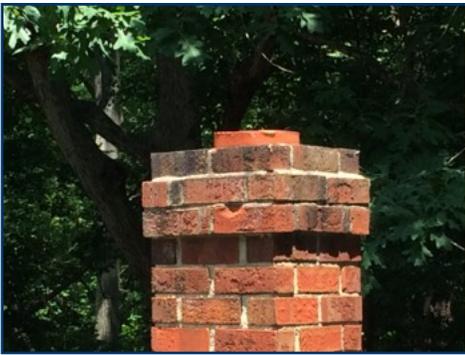
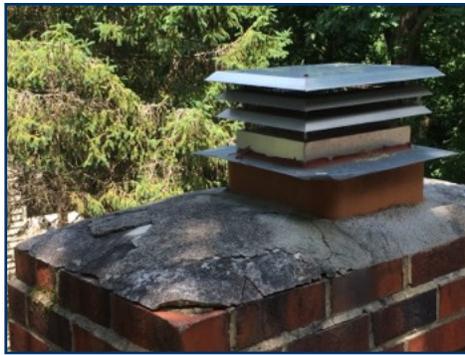
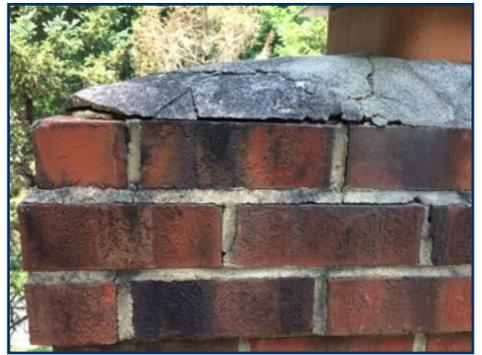
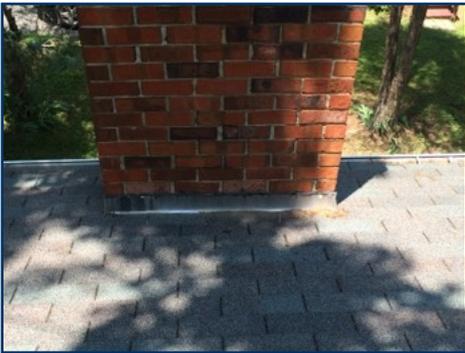
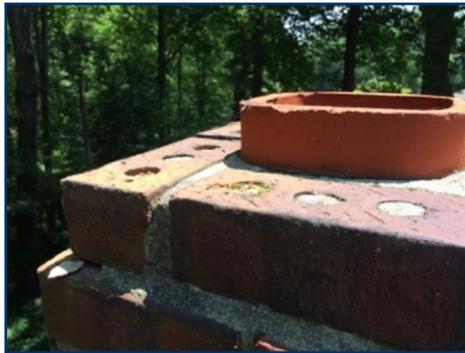
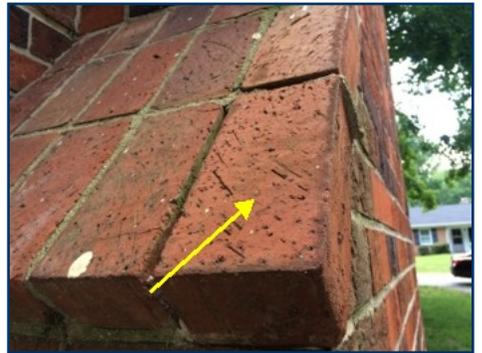
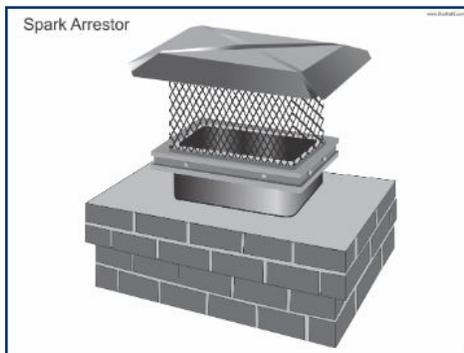
6.1. Chimneys wider than 30" require a cricket behind them to help shed water and prevent leaks. I recommend having a cricket constructed behind the chimney by a qualified contractor. (\$250-\$500+)

6.2. There was no spark arrestor and no **crowft** installed on the **flue** of the smaller chimney. This will allow precipitation and animals to get into the house, and can allow burning embers to escape. I recommend having a qualified chimney tech or contractor install a spark arrestor and add a **crowft**. (\$300-\$700+)

6.3. The chimney **crowft** on the larger chimney is cracked or damaged and some mortar joints have deteriorated. The **crowft** prevents moisture intrusion into the chimney. I recommend having a qualified mason repair or replace the damaged **crowft** and mortar. (\$300-\$600+)

6.4. Mortar deterioration and loose bricks were observed at the chimney near the base. I recommend having a qualified chimney tech repoint and repair as needed. (\$300-\$500+)

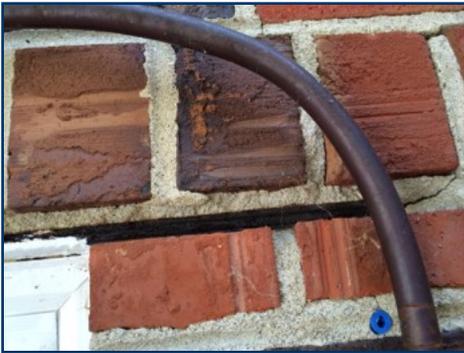
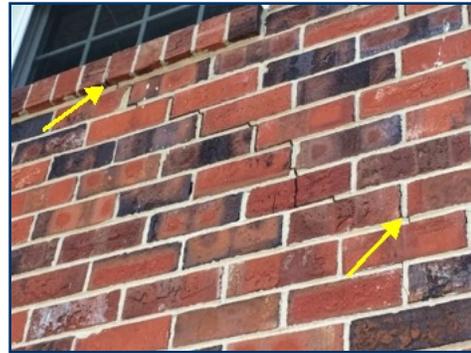
1.1. The brick veneer had moderate step cracks. They cracks did not appear to be structural in nature. However, further damage will result from moisture intrusion and freeze thaw cycles. I recommend having a qualified mason properly seal or repoint all cracks in the brick veneer.

1.2. The lintel above the basement door on the right side of the house was rusting. Further rusting can result in significant damage to surround brick. I recommend having the lintels treated for corrosion and painted to protect them from the elements.

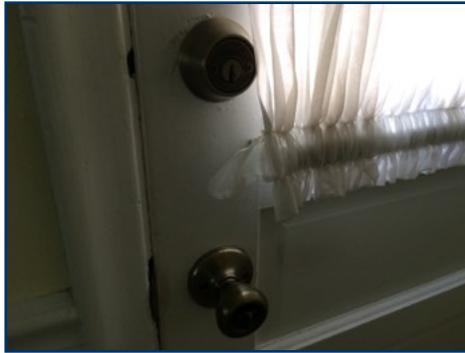
3.1. The exterior doors had dead bolts that require a key on both sides. Doors should not require keys, or special knowledge to exit. I recommend having this corrected by a qualified contractor. (\$200-\$300+)

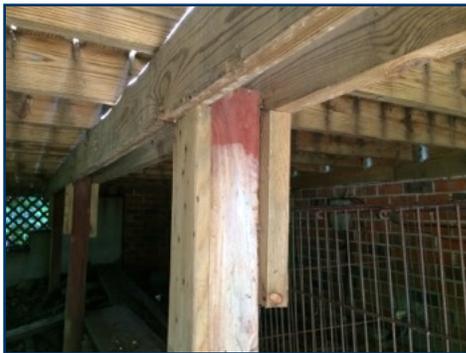
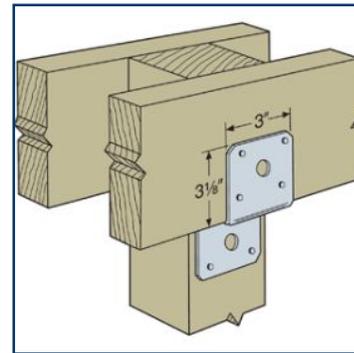
5.1. The wooden posts were in contact with soil. You should monitor these areas for rot.

5.2. The deck beams were nailed to the side of the post. Beams should generally not rely on the shear strength of nails. Jack studs or retrofit brackets are typically needed to repair this condition. I recommend having a qualified contractor repair as needed. (\$125-\$225+)

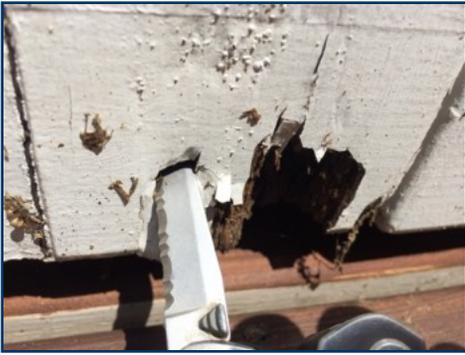
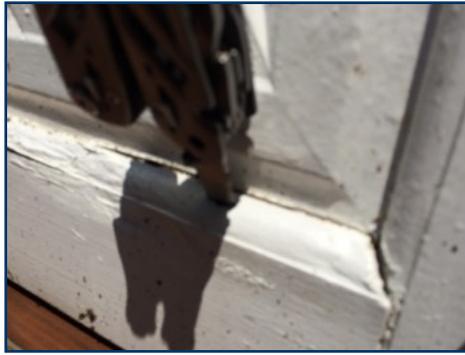
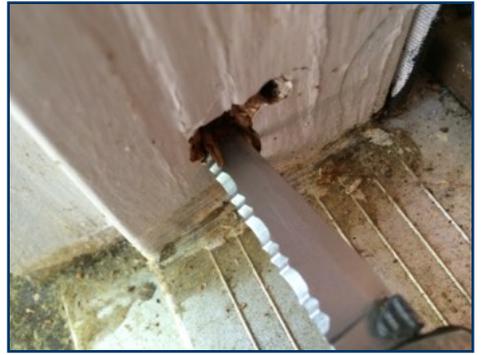
8.1. There was some rot observed at the trim of the rear deck door and the shed door. I recommend having a qualified contractor repair as needed. (\$75-\$150+)

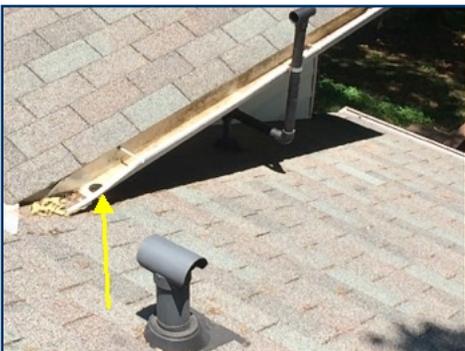
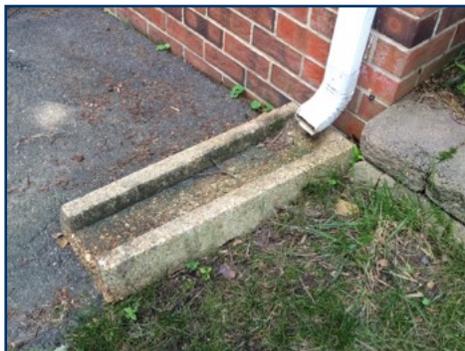
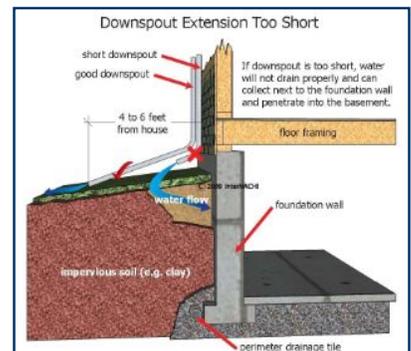
12.1. Splash blocks were observed at the bottom of the down spouts. Although their use is common, they are not usually effective at distributing rain water away from the foundation. I recommend monitoring these areas. If you notice large puddles around them, or erosion, it will be prudent to utilize a better method of moving the water away.

12.2. Some of the downspouts terminated too closely to the foundation. This concentrates water at the foundation and cause moisture intrusion into the foundation. I recommend having the downspouts extended 4-8 ft from the house. (\$50-\$100+)

12.3. There were gutters with no downspouts above the roof. They may reduce the life of the roof coverings they discharge onto. You may wish to extend the downspout to the ground.

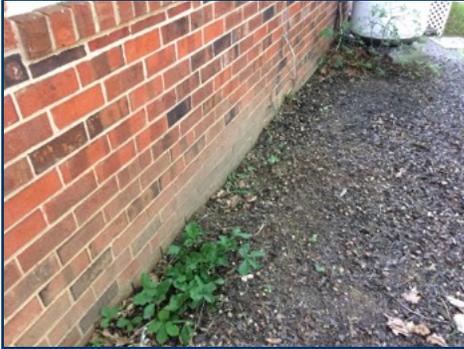
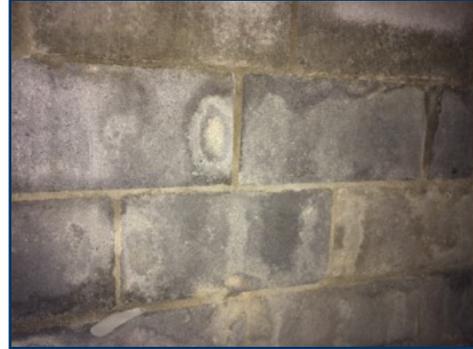
13.1. There are some low spots along the foundation and moisture staining on the foundation walls in the crawlspace. I recommend adding additional backfill to create the proper slope away from the house to allow for effective drainage.

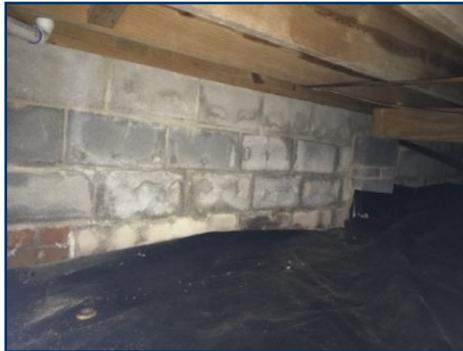
2.1. Stains visible on the interior surfaces of the foundation wall in the crawlspace appeared to be the result of moisture intrusion due to low spots of erosion around the house and downspouts discharging too close to the foundation. Moisture intrusion can result in damage to the home structure or materials and may result in conditions which encourage the growth of microbes such as mold. See Grading and surface drainage section for recommendation.

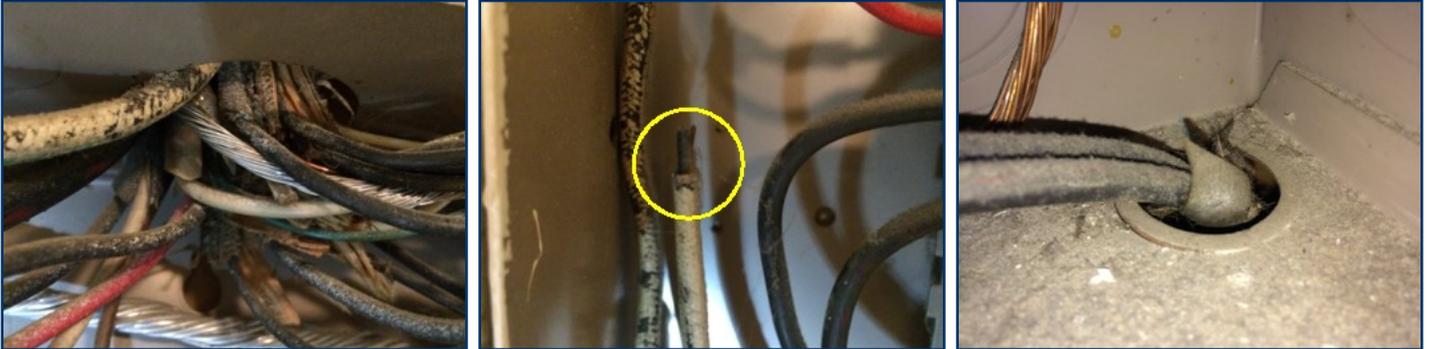
5.1. There were **romex** cables that were not properly clamped to the box. The edges of the box are sharp so clamps or bushings are required to avoid damage to the cable. I recommend having an electrician correct as needed. (\$75+)

5.2. There were open knockouts in the panel. Insects and small pests can get into the panel and damage the cables. I recommend having a qualified electrician repair as needed. (\$100+)

I recommend having a wire nut installed on any cut wires in the panel.

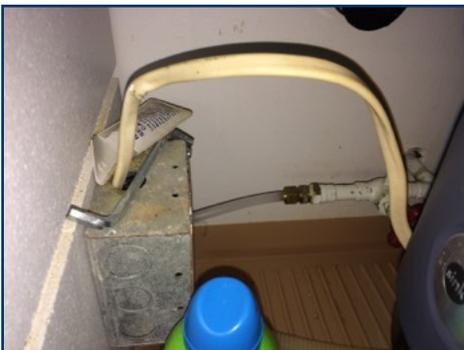
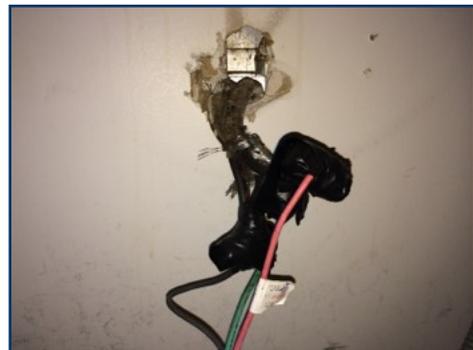
7.1. There was an open splice observed in the cabinet under the stove. This is a safety concern. I recommend having a qualified electrician repair as needed. (\$100+)

7.2. There was unprotected wiring under the kitchen sink. Cables subject to damage need to be protected and cables under the kitchen sink are generally considered to be subject to damage. I recommend having a qualified electrician correct as needed. (\$100+)

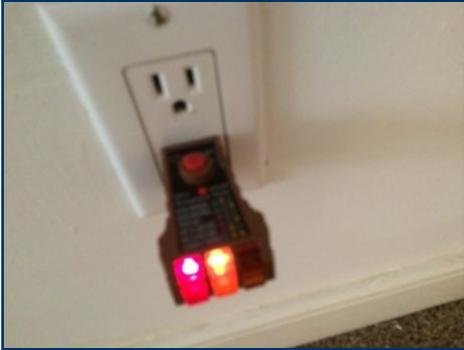
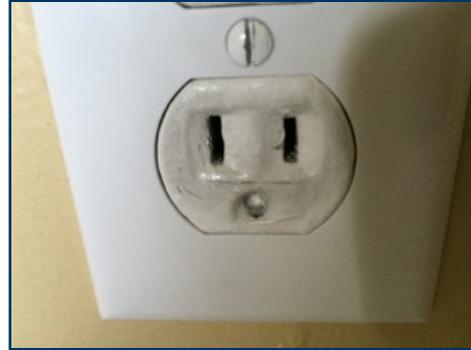
8.1. Many outlets had been painted over, were full of paint and could not be tested. Outlets that were painted over are safety concerns and should be replaced. I recommend having a qualified electrician replace outlets that have been painted over. (\$25-\$40 per outlet)

8.2. There was an outlet that had reverse polarity in the upstairs bedroom. I recommend having a qualified electrician repair as needed. (\$75+)

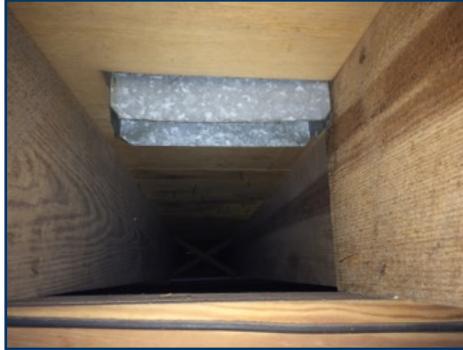
5.1. There was a open supply vent in the living room with no ductwork attached. I recommend having this sealed off or properly attached by a qualified contractor.

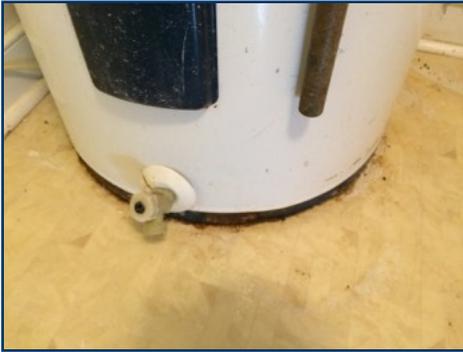
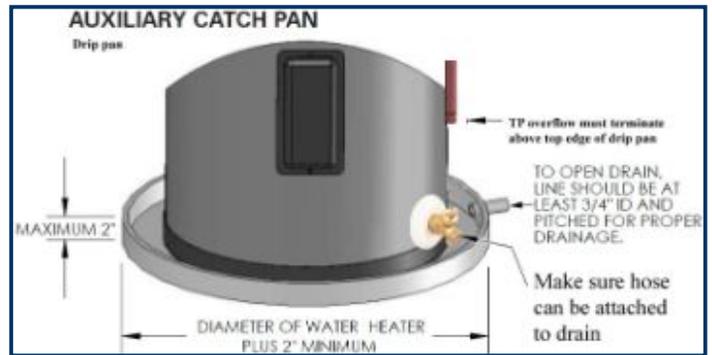
3.1. There was no drip pan installed for the water heater. Drip pans that convey water to the outside are required where water heater leaks can cause damage. I recommend the installation of a water heater drain pan. (\$150-\$250+)

3.2. The TPRV was leaking. This is a safety concern. I recommend having a qualified plumber repair as needed. (\$75-\$125+)

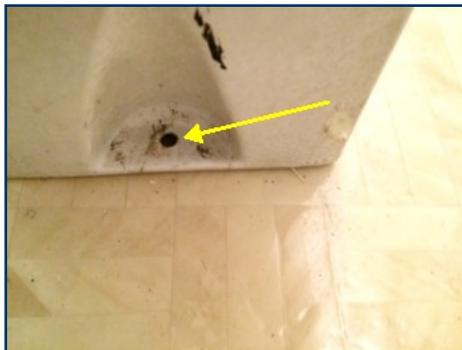
5.1. The pedestal sink in the downstairs bathroom was not secured to the floor. Most manufacturers require that the base be adhered or screwed/bolted to the floor, to prevent personal injury. I recommend having this corrected (\$50+)

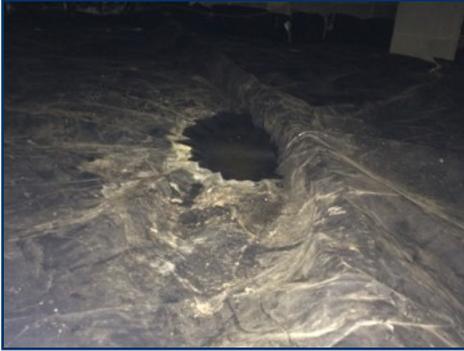
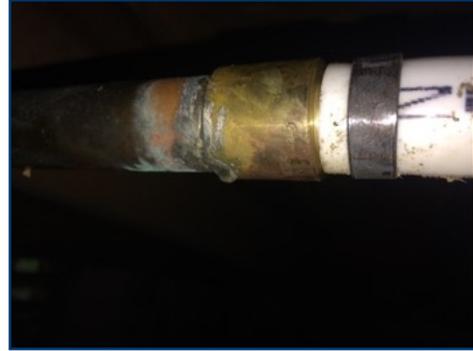
6.1. There was a pipe leaking in the crawlspace near the left front corner. A qualified plumber should repair as needed. (\$100-\$175+)

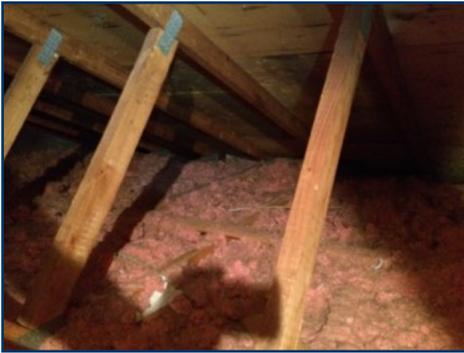
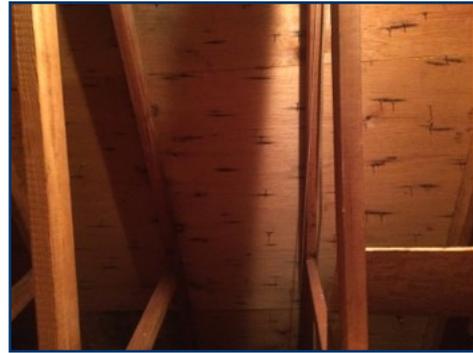
1.1. There were black stains around all of the nails in the attic. This occurs in the winter when warm moist air from the home rises to the attic and condenses on the cold nails. I recommend discussing your options to prevent this with a qualified contractor.

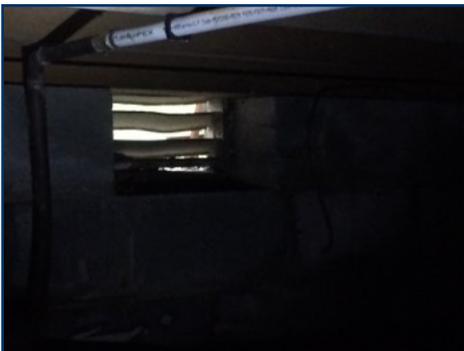
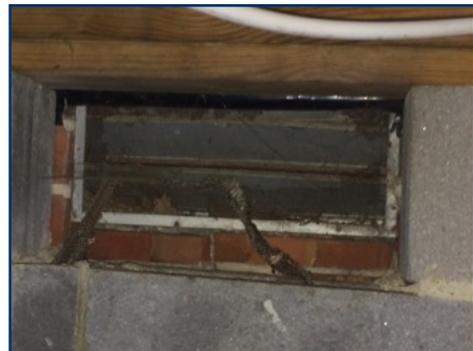
2.1. There was no insulation in the crawlspace. Depending on how long you plan to own the home, having insulation installed may be cost effective.

2.2. Many of the crawlspace vents were missing screens. Screens prevent pests from infesting the crawlspace. I recommend having a screens installed.

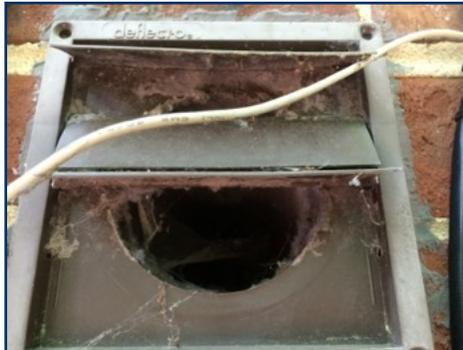
4.1. The dryer vent **dampel** was broken. Small rodents, birds or insects may crawl into the house through this vent. I recommend having the **dampel** replaced.

4.3. The dryer vent was dirty. Dirty dryer vents are prone to fires. I recommend having the dryer vent cleaned now and at least once a year.

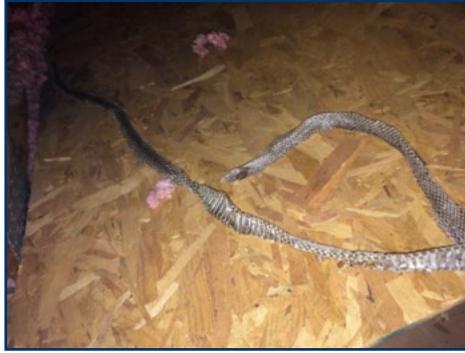
4.1. There were snake skins observed in the attic. I recommend a pest control specialist further evaluate and treat as needed.
